## Sol-20 Restoration

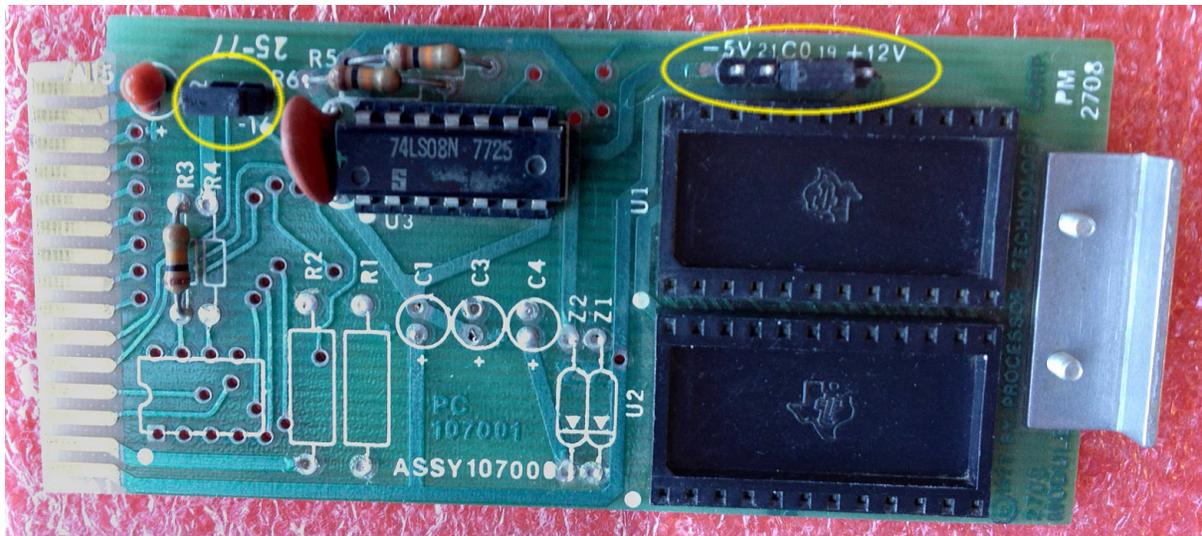
**Personality Module Jumper Modification**

To make the board easy to use for any of the above combinations, I cut the default jumper traces on the PCB (-16, C0 to 21, 19 to +12v) and installed header pins in each jumper position. This allows use of standard push-on jumpers to select different options. Note that using 2708's requires installation of the parts missing on the PCB shown below in order to generate -5v for the the 2708's.

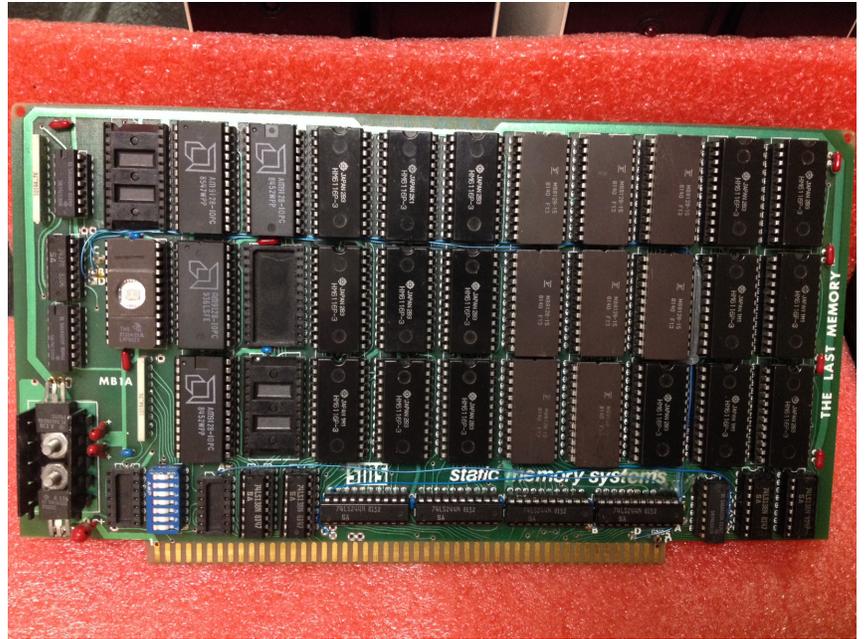
As shown in the picture, the sockets at C000-C7FF and C800-CFFF are empty to leave room for SOLOS at C000-C7FF and for RAM and video RAM at C800-CFFF. The socket for F800-FFFF is also empty as I have a Micropolis FDC in this address space. Finally, an EPROM is installed at F000-F8FF in which I have burned an Intel hex file loader. RAM is installed from D000-EFFF, but most software won't know about this RAM or be able to use it.
