Restoration and Repair of a Pertec 3202 Dual Drive Cabinet

I obtained a rack-mount version of the Pertec 3202 dual drive cabinet without drives and without a top cover. This unit has the tan/brown ICOM color scheme instead of Altair blue/black.

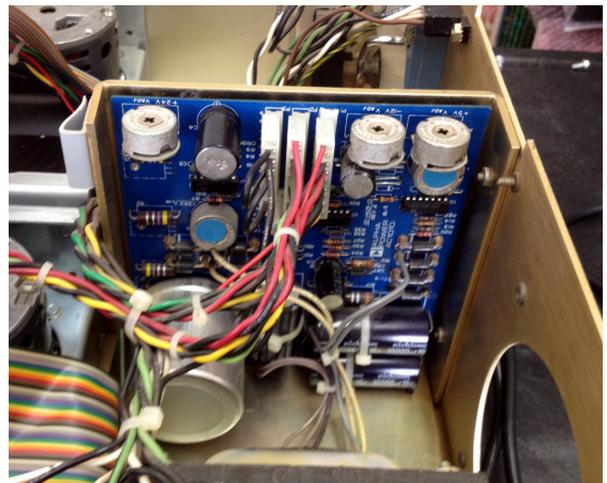
With the 3202, MITS/Pertec went with an off-the-shelf power supply for the first time instead of designing their own. The power supply is in the back right hand side when the cabinet is viewed from the front.

With no load, the power supply outputs looked reasonable, however, after a few tests under load, it was clear that the voltage adjustment pots and connectors needed some contact cleaner and cycling to remove oxidation. I cycled the pots back and forth numerous times after spraying in a bit of contact cleaner. Voltage adjustment was then smooth instead of “jumpy.” Cycling of the three DC output connectors on the power supply numerous times fixed intermittent voltage “jumps” at the load.

Unlike the Altair single drive cabinets which supply -5v to the drive, the 3202 provides -12v to the drive.

Both the FD-400 and the FD-510 drives can work with either -5v or -12v, but the W1 or W2 jumper must be installed on the drive to properly select -5v or -12v operation. ***Connecting a drive configured for -5v to the -12v supply in the 3202 will damage the drive!***

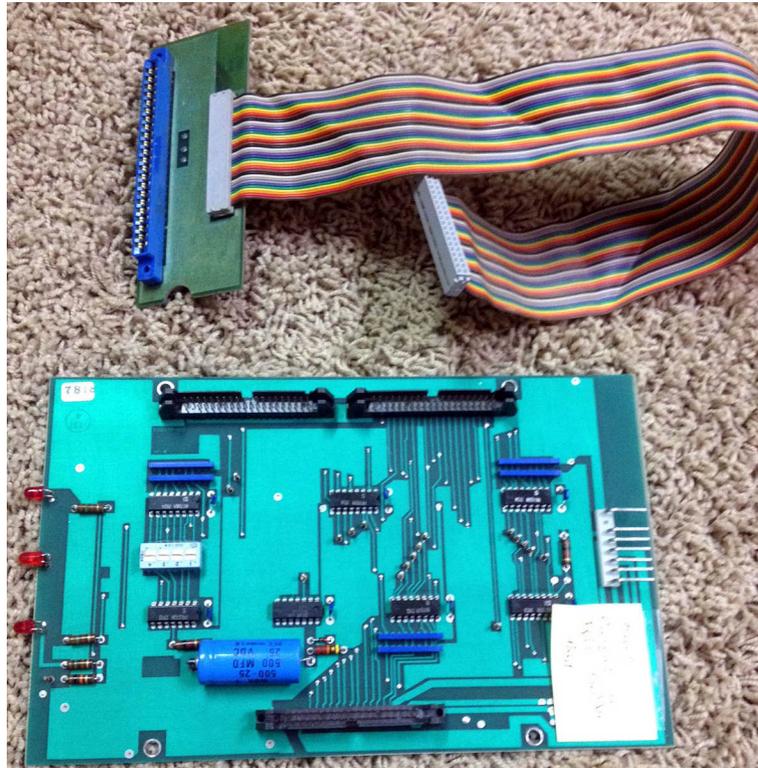
C1 is a large, 500uf capacitor, that along with one-shot U3, provides a 4-5 second delay when the drive is powered up or a disk is inserted. During this period, the “ready” line back to the controller is inhibited. This is primarily for the FD-400 DC motors to give them time to spin up and stabilize, but this one-shot is present in the 3202 buffer board as well, even though the FD-510 drive used in the 3202 uses an AC motor which spins the hub all the time.

Two of the buffer boards had a failed C1. One capacitor was a dead short which caused the drive to never become ready, the second had the capacitor installed backwards which damaged the polarized capacitor. The third board had one lead of the capacitor clipped off. This results in no ready delay at all and was a fairly common field modification. I replaced all three capacitors with 330uf capacitors (because that’s what I had handy), and now the ready line on all three buffer boards operate as designed with a delay of about 4 seconds.

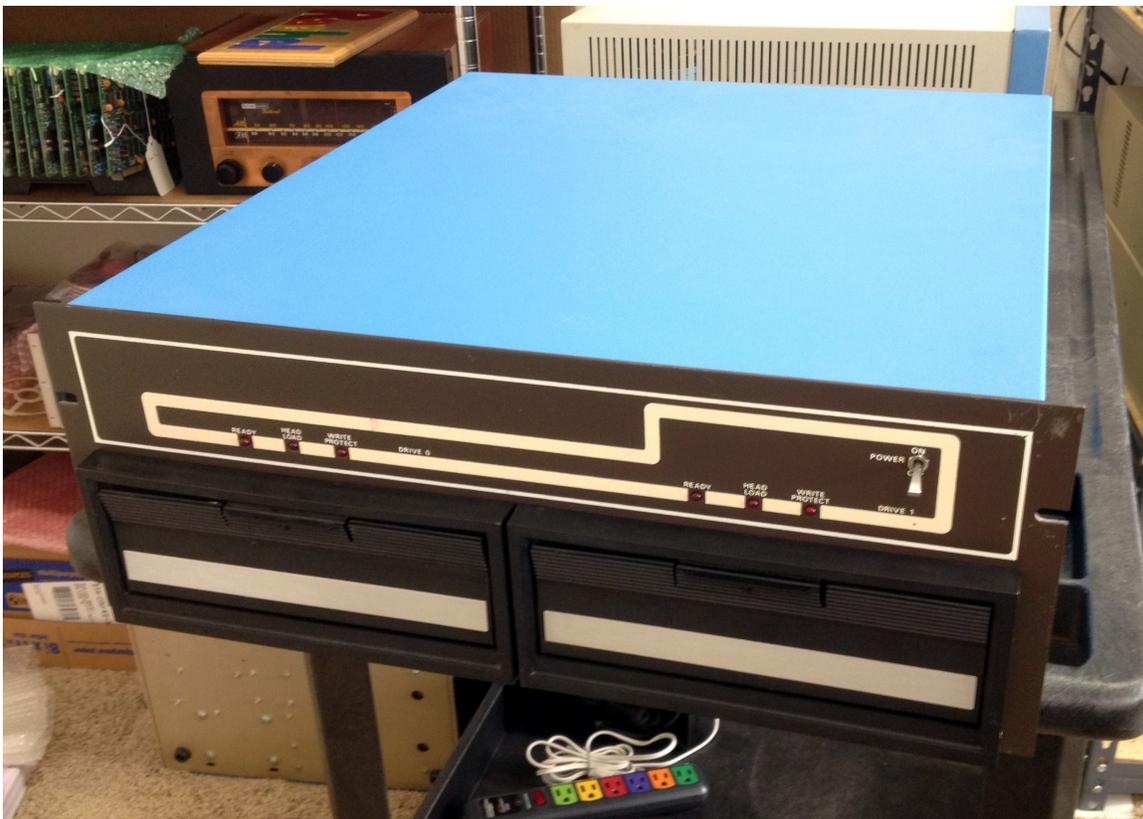
A friend bent a cover for the cabinet for me and I had it painted using the Altair blue paint I have at the paint shop for the Altair 8800 Clone. This is the result:
