Altair 8 inch Floppy Drive Restoration Notes

This is a later version of the Altair floppy that uses ribbon cables and IDC connectors internally instead of hand-wired ribbon cables. The buffer board combines the buffering electronics with the power supply electronics on a single board. Both the front panel and the buffer board include a write protect LED position, so if the drive is equipped with the write protect electronics, the front panel LED should illuminate when protected.

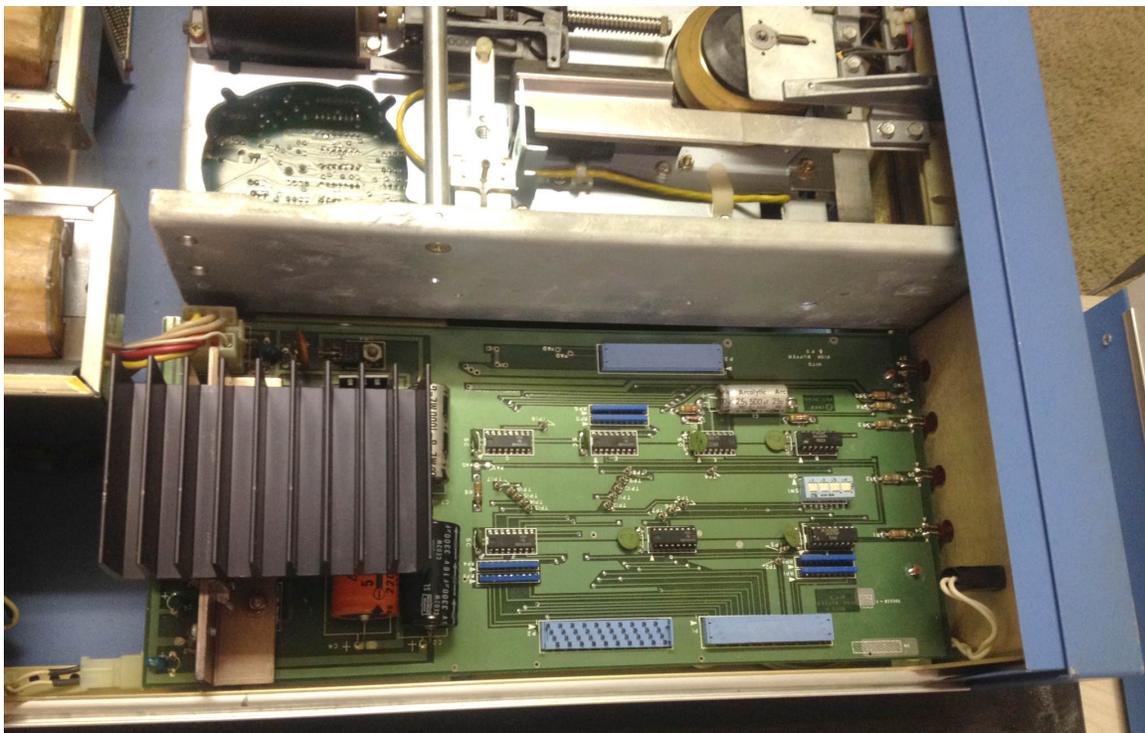
The drive was received with all ribbon cables removed from the rear panel and buffer board connectors, but the IDC connectors were left in place. The card-edge adapter board for connecting to the drive was not present either.

Buffer Board Inside Drive Cabinet (Original Condition)

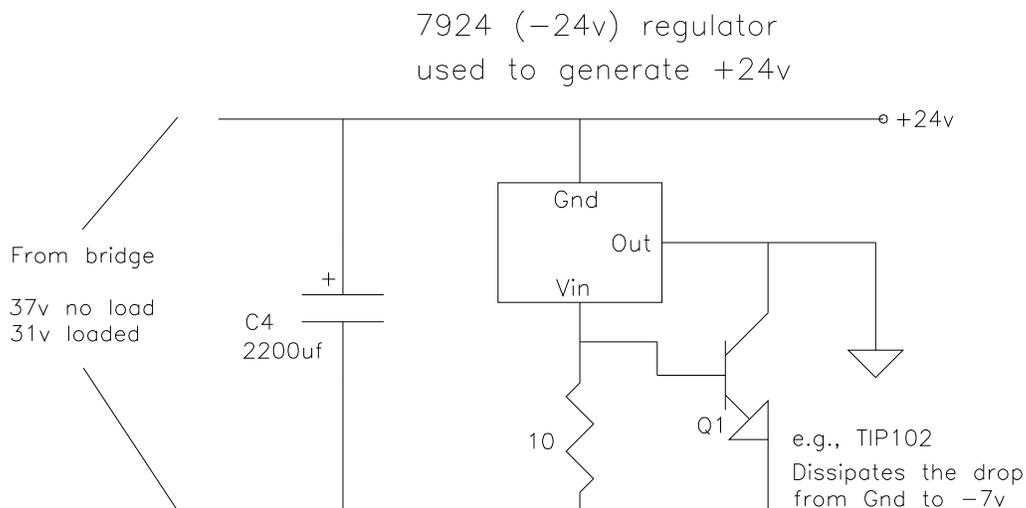
First, I replaced the burnt out socket for the 24v pass transistor, but still no output on the 24v supply. The 24v supply uses a -24v regulator to generate +24v. A reverse-engineered schematic of the supply is shown below. Note that the minus side of filter cap is not ground. Instead, the positive side of the filter cap is clamped to +24v by the regulator which is referenced to ground.

The remainder of the filter cap voltage is dissipated by a pass transistor from ground to the negative side of the filter cap.

I determined the pass transistor was bad and replaced it with a TIP102. The TIP102's I had have very wide leads and I had to trim them lengthwise to fit in the socket. After replacing the transistor, the 24v supply looks good. There is 37.5v across the filter cap with the motor off, so the pass transistor is dropping 13.5v from ground to the minus side of the filter cap. With the motor on, there is 31v across the filter cap, so the pass transistor is dropping 7v.

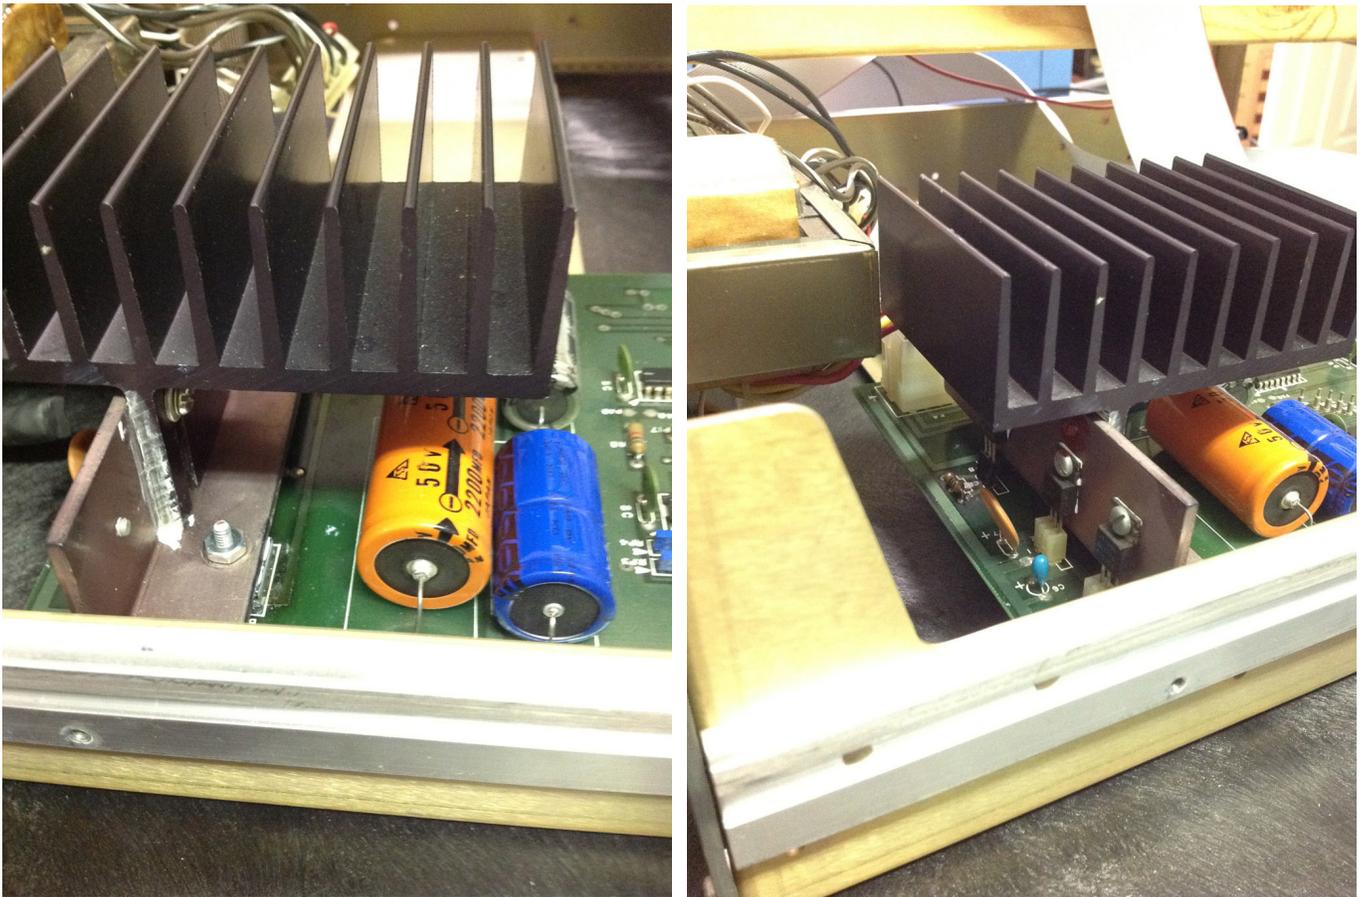
Two regulators and a transistor mount vertically to the bronze colored L-bracket under the large black heat sink as shown in the picture on the first page. These three TO-220 style parts connect to the main buffer board via three pin sockets. The transistor is part of the 24vdc motor power supply. The socket had burnt from self-heating. The socket must carry 2-3 amps and this pushes the max rating of these sockets. The bracket also clamps onto two flat bridge rectifier packages with heat-sink grease. Unfortunately, this joint must be pulled apart every time you need to work on the buffer board. (See pictures are on the following page)

Heat Sink and Socketed High-Current Components

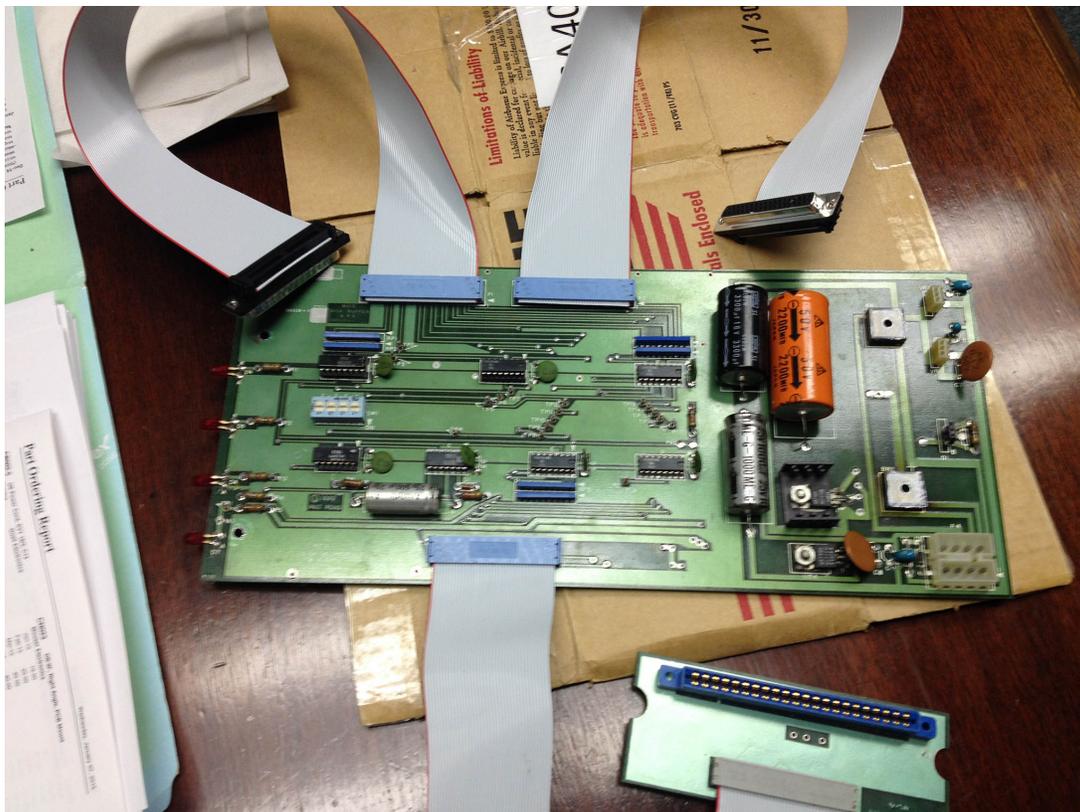
Connector P2 on the buffer board connects to the incoming DB37-M connector. P1 connects to the outgoing DB37-F connector. I discovered that P2 pin 1 (Disk Power/Ready) was shorted to ground. I traced the signal to IC G pin 13 (74LS367 or 8T97). I lifted pin 13 and the short went away on the PCB. The short was still present on the pin itself indicating a damaged IC. I replaced the 74LS367 and the short is gone.

Buffer Board with New Ribbon Cables

I built and added all three ribbon cables. I used the 3202 drive adapter shown in a previous picture and installed a new ribbon cable to allow connection to this buffer board. A photo on the next pages shows the buffer board with the new cables installed.

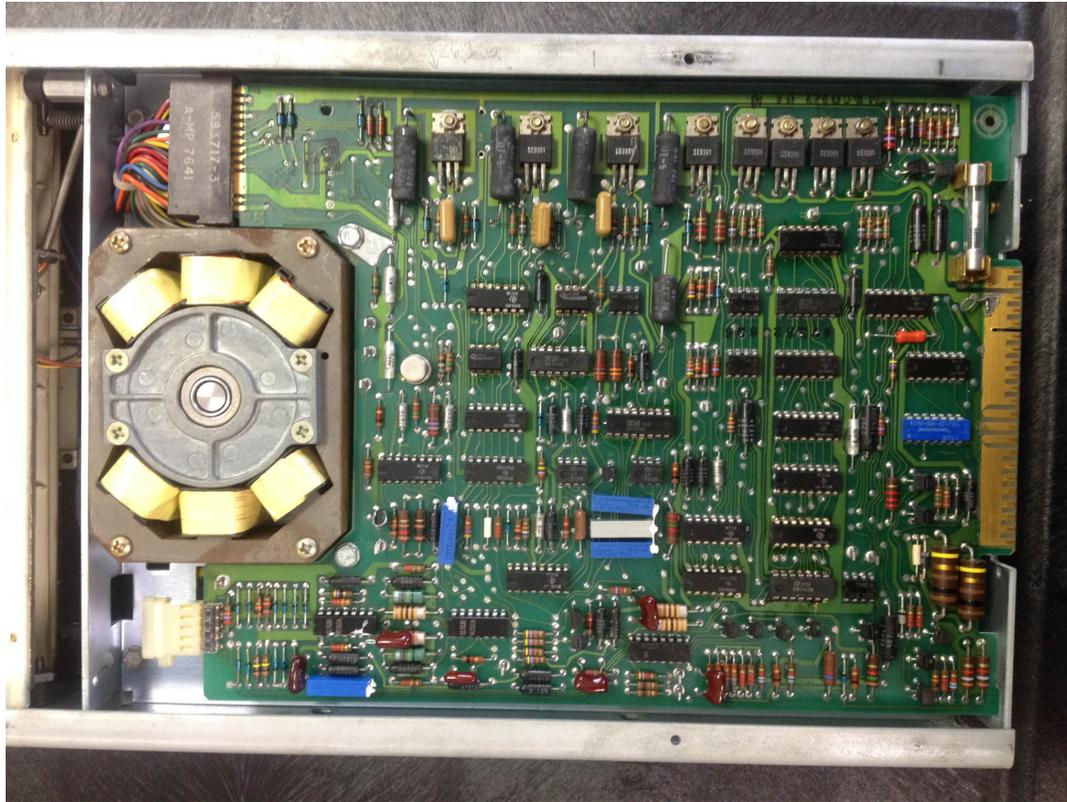
The first steps were a simple cleaning, removal of some rust, a bit of lubrication, etc. On first test, the motor started sometimes, but seized up most times. Looking at the drive PCB, it is clear the previous owner had replaced all eight power transistors (Q1-Q4, Q24-Q27) and seven IC's. Looking on a scope, the waveform at Q27 (phase C) was bad. I replaced Q27 with a new TIP-102. As part of this repair, I removed the PCB from the drive and noticed a problem with a contact in the internal-wiring edge connector (J2). One card-edge finger was bent completely backwards and was shorting against the opposite row of pins. The bent pin happened to be the signal from Q27 to the phase C coil. This short is probably what damaged Q27. I bent back the contact (very marginal condition, needs to be replaced), and with the new transistor, the drive motor now starts and runs much more reliably, but still stops now and then after it's been on for a while.

Drive PCB

Looking at sector pulses from the drive with a disk installed, the pulses are steady for a while, but as the electronics heat up, the motor transitions to an unstable state in which the sector pulse timing waves in and out like an accordion, cycling 2-3 times a second. The motor bearings seem to spin freely, plus the problem starts instantly when it occurs, so it appears to be some sort of trip point in the electronics that starts the problem.

Once the problem started occurring, the waveform on Q26 changed (motor phase B coil). Replacing Q26 seemed to fix the problem at first, but eventually the problem returned.

Further probing revealed that the 5v supply on the drive PCB is dipping at 120hz intervals when the problem is occurring, but not when the motor is stable. Droops get as much as -0.4volts. The motor issue could be caused by the 5v droop changing the base current in the coil transistors and causing the oscillation. Or, the 5v droop could be a symptom of current spikes once the motor becomes unstable.

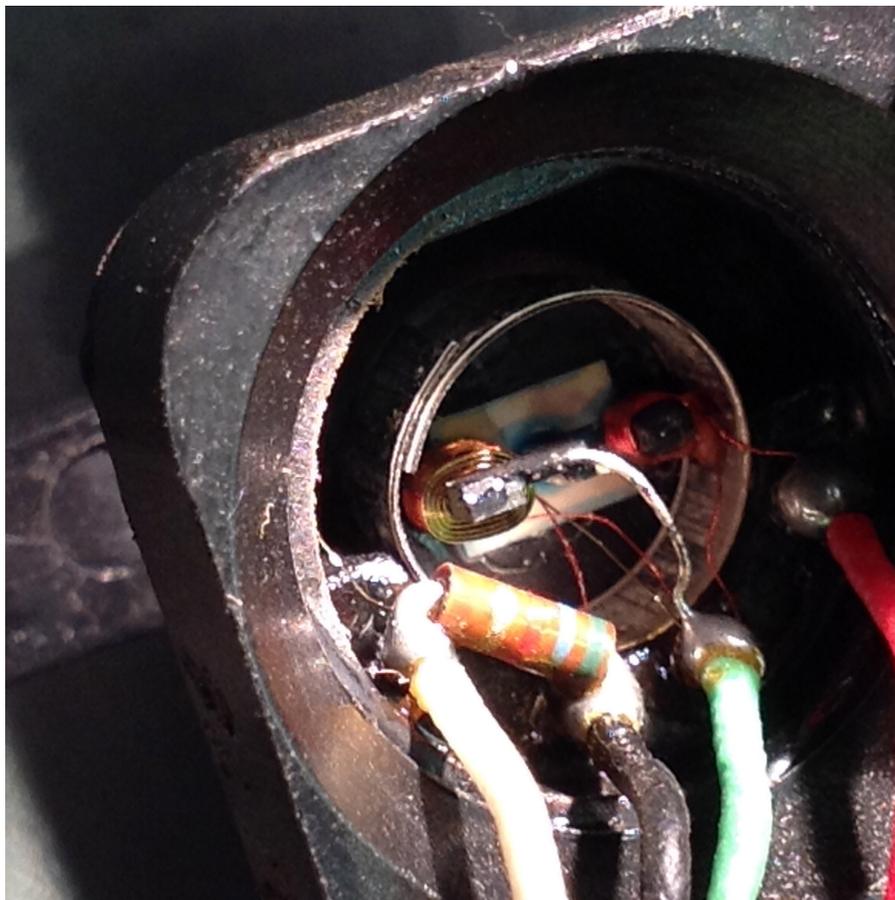
Writing a disk produces garbage. Looking on a scope, the two R/W coils don't have symmetrical waveforms during write (generated by Q17 and Q18). I measured resistance of the coils from the head write connector on the PCB. One R/W coil measured 6.8 ohms, the other measured 4.8K. Upon disassembly of the head mechanism, the side that measures 4.8K has a broken coil wire that can't be re-attached. The 4.8K measurement is because a 5.6K resistor is still attached inside the head between the two coils. A new head will be needed. Without differential signals coming from two coils, the read data will be very unreliable and this explains why the disks wouldn't boot even though I frequently saw valid looking data. A picture inside the head is on the next page.

Broken Head Wire to Left of White Wire

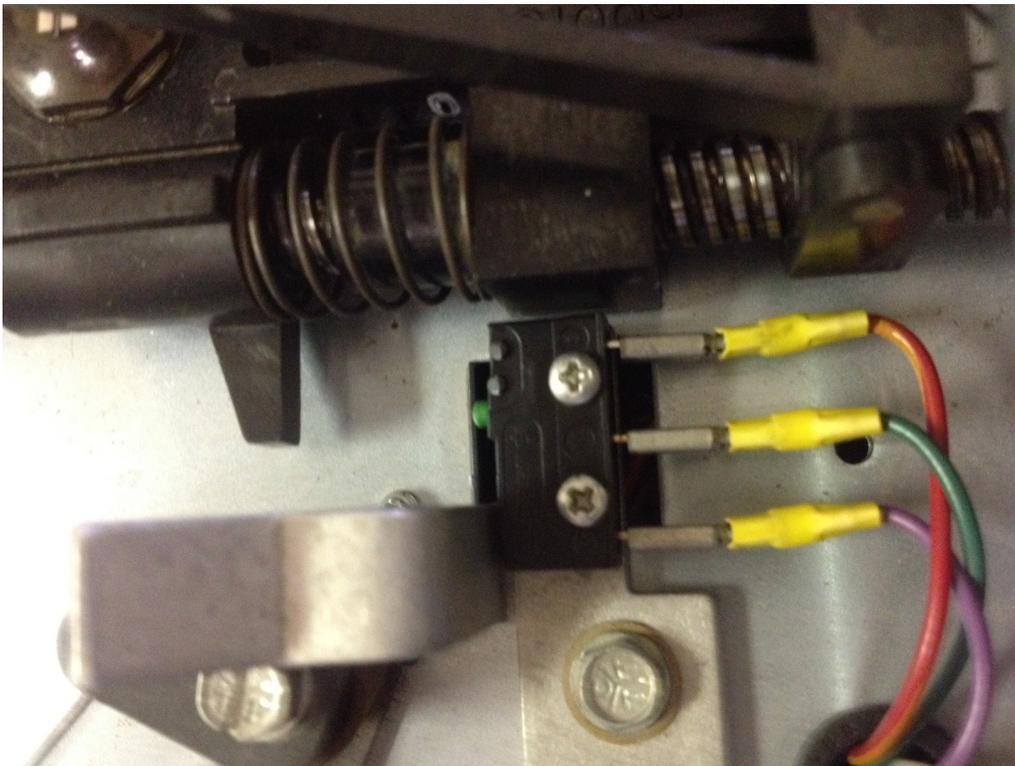
The drive over-shoots track 0 when seeking home. The track 0 switch comes on properly as the head moves from track 1 to track 0. So the drive shouldn't overshoot even if the track 0 mechanical stop is not properly adjusted.

The Pertec drive delays the track 0 signal to the drive for 50ms after the signal is asserted internally. A seek to zero algorithm on the 8080 steps every 10ms looking for the track 0 signal to be asserted. This delay means the software will issue 4-5 additional step out commands after the drive is actually at track 0. The drive is designed to ignore additional step out commands once track 0 is reached. The internal track 0 signal is supposed to be active within 9ms (i.e., less than the minimum track step time). This internal track 0 signal blocks additional step out commands from activating the stepper motor via an AND gate. On this drive, however, the internal signal took 35ms or so to activate. This allows three or so extra step outs to reach the stepper motor. I shot some contact cleaner in around the plunger on the switch and this reduced activation time to right about 10ms. Problem is much better, but I can tell I'm still getting an extra step out now and then. I may need a new switch to stay reliably under 10ms.

New Track Zero Switch

Update: The switch gets worse (slower) after I don't use the drive for a while. Though a part number is not on the switch, "Cherry" is present. Most likely it is a E6300A0 which has been discontinued. The closest replacement is the Cherry DB3C-B1AA. I purchased and installed the new switch. It was a quick and easy drop-in replacement and fixed the problem. A picture with the new switch is shown below.

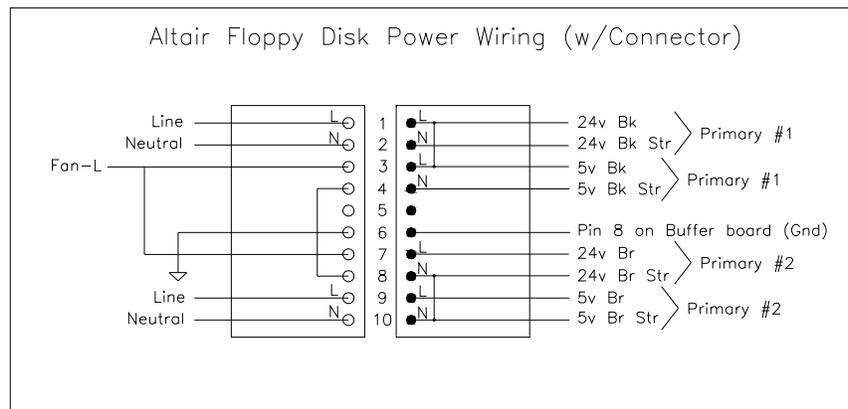
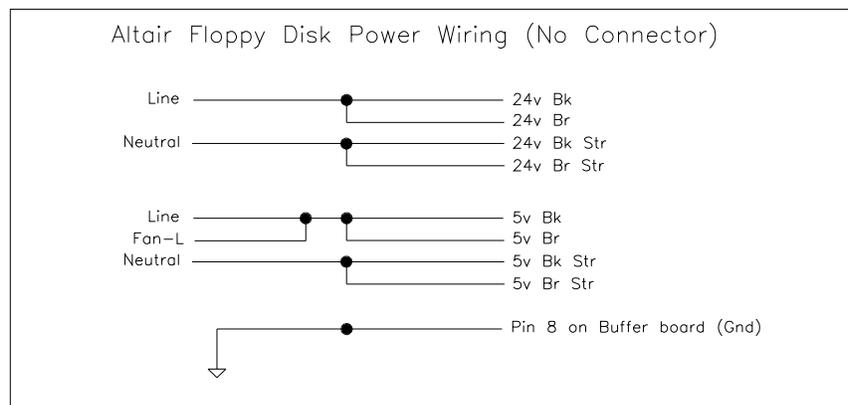
As I manipulated the connector between the 120vac input filter and the transformer primaries, 5v power to the buffer board and drive would occasionally cut off. This may indicate a bad crimp, and if shared between the 24v and 5v transformers, could explain why additional current draw on the 24v line affects the 5v line.

Update: About a week later, after bending wires around to fully re-assemble the cabinet for the first time, I noticed the voltage on the 5v filter cap voltage was dropping with the 24v load again. The minimum voltage is staying above 7v (for now), but the root problem has not been fixed. I will probably eliminate this connector completely and hardwire AC inputs to the transformer primaries.

Update: I cut out the connector completely and hardwired the transformer primaries to the AC input. This eliminates the problematic connector and also simplifies the wiring. With this work, the 5v supply again looks good. The voltage on the 5v supply filter capacitor is about 10v and is not affected by 24v load changes. Removing the connector may also eliminate the need for the 4.7uf capacitor in parallel with the main filter capacitor, but there is no real need to remove the 4.7uf now that it is already soldered in place. The following diagrams illustrate wiring before and after removing the connectors.
