Altair 8 inch Floppy Drive Restoration Notes

This is an early version of the Altair 8" drive. It uses the first version of the Pertec FD-400 drive with an aluminum door and the 600191 PCB. The buffer board includes a user-installed modification that makes the power light flicker while the motor is spinning with a disk inserted. This was probably so the user could verify the hub motor was still spinning. The motor on these drives could seize and stop spinning, and if left that way too long, damage drive electronics.

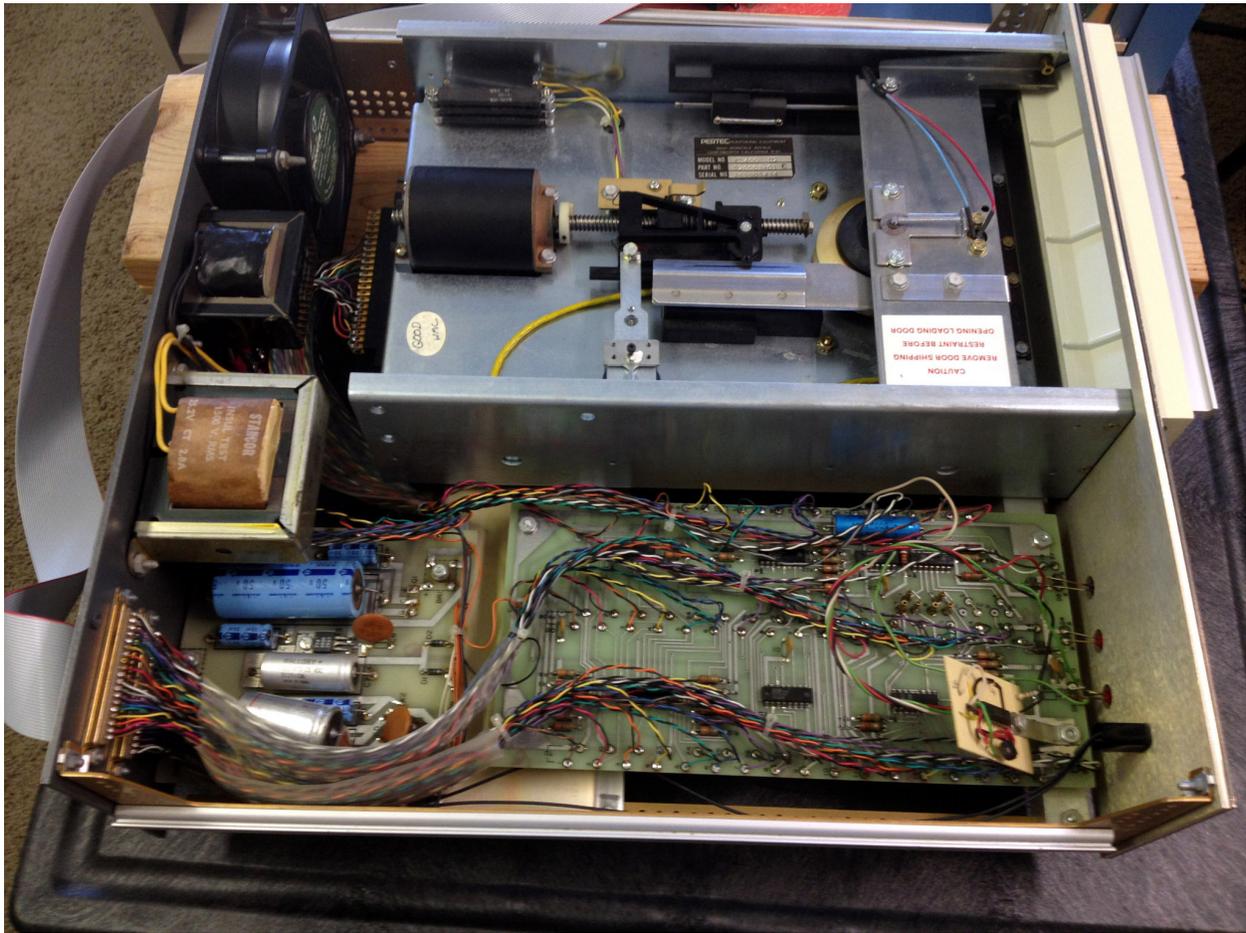
In the photo above, the mod for flickering the power LED is on the small angled board at the bottom right corner.

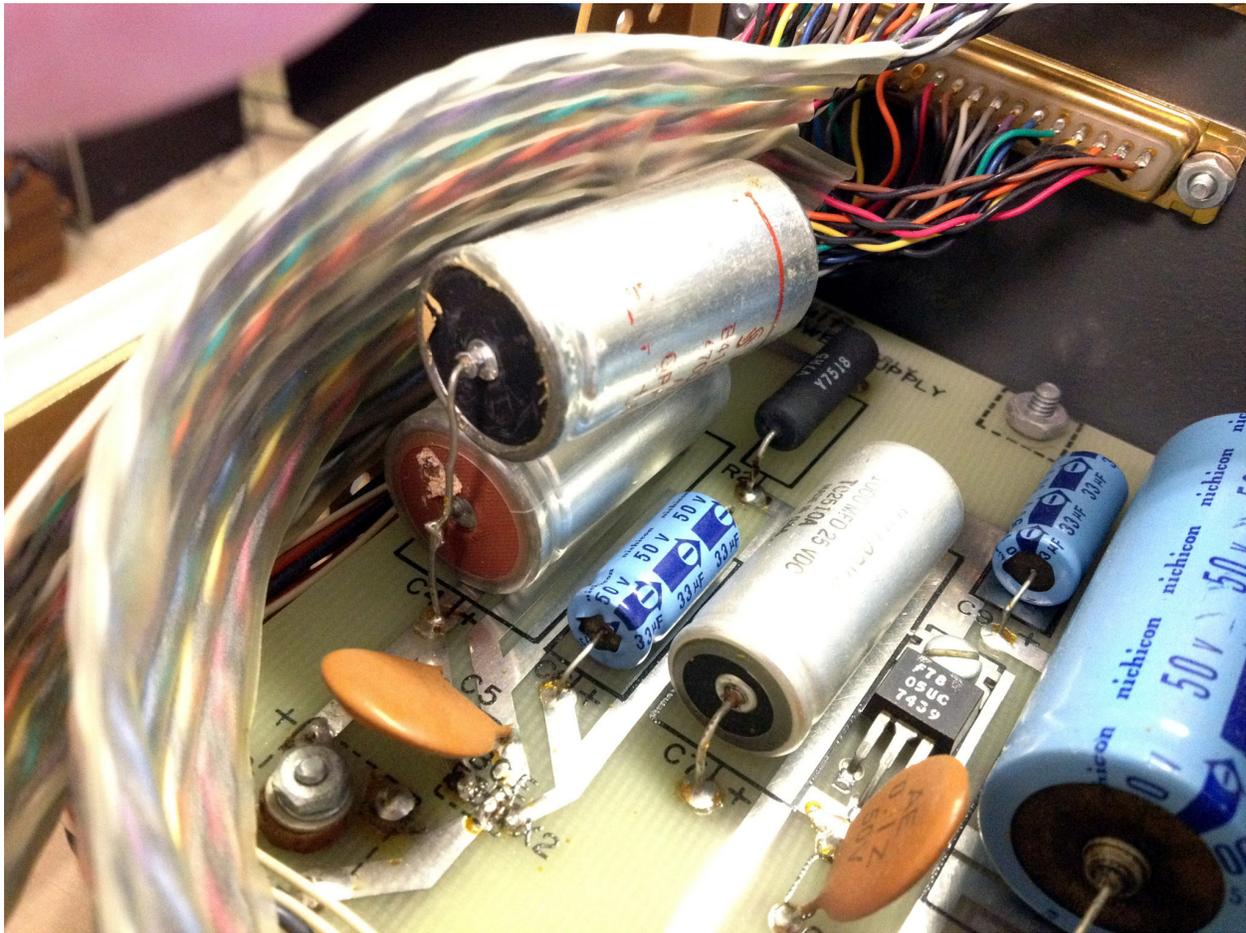
Original 5v Filter Caps

An additional 4700uf capacitor has been soldered in parallel onto the original 3300uf filter cap for the 5 volt supply (see pictures on next page). Both capacitors show signs of leakage, though the 5 volt supply still looks good. I replaced the two capacitors with a single 8200uf capacitor (not shown).

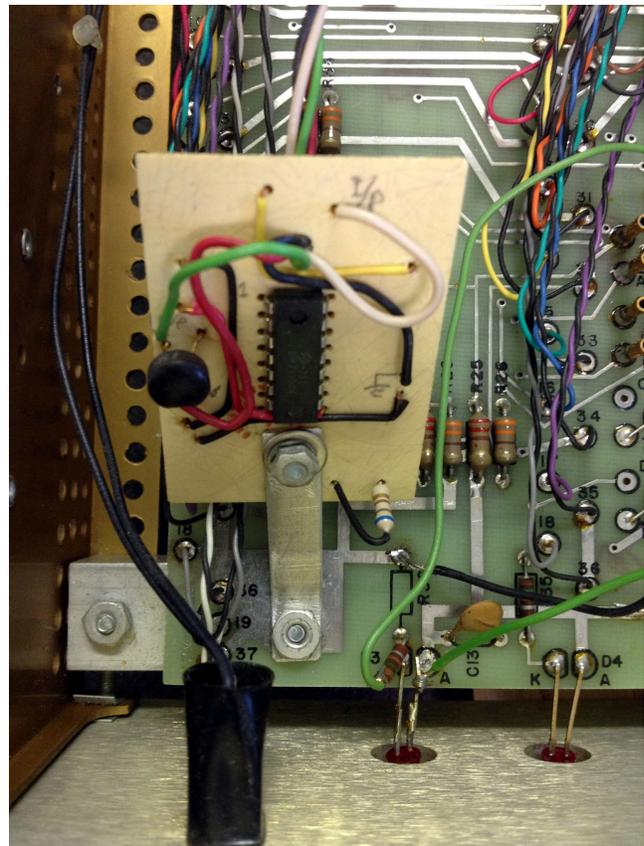
The proto-board added for the motor-spinning mod is shown to the right. This board taps into +5 (red), ground (black), sector pulses (white), and the power LED anode (green).

When a disk is inserted and spinning, 32 sector pulses, plus one index pulse, go by each revolution. There are six revolutions per second for a total of 198 pulses per second. The 7490 on the board divides this by ten and modulates the power LED via its anode at 19.8hz. If the disk stops spinning (or no disk is inserted but the door is closed), the power light is steady on.
