## Altair 8800b Restoration

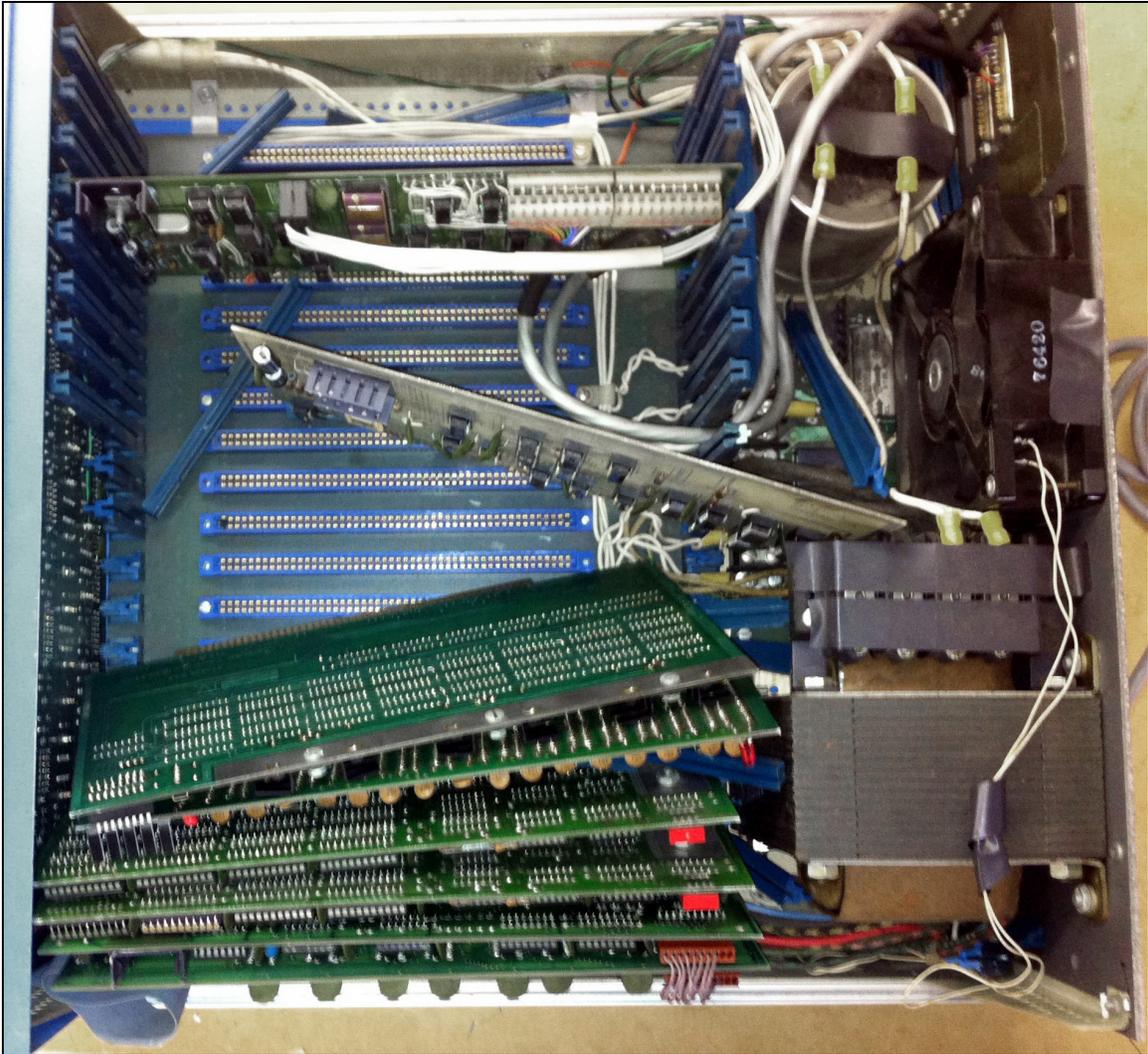
I purchased this Altair 8800b through eBay. This is a very heavy computer, especially in the corner with the enormous transformer. Unfortunately, the seller shipped the computer with all boards still inside the computer instead of packed in a separate box as I requested. This resulted in over half of the card guides being broken and the boards coming loose and inflicting some damage on each other.

I removed the motherboard so I could unscrew and remove the broken card guides. I decided to remove even the unbroken card guides to make access to boards, the power supply, and the back side of the front panel easier. In general, there is no issue with running the computer without card guides on installed boards.

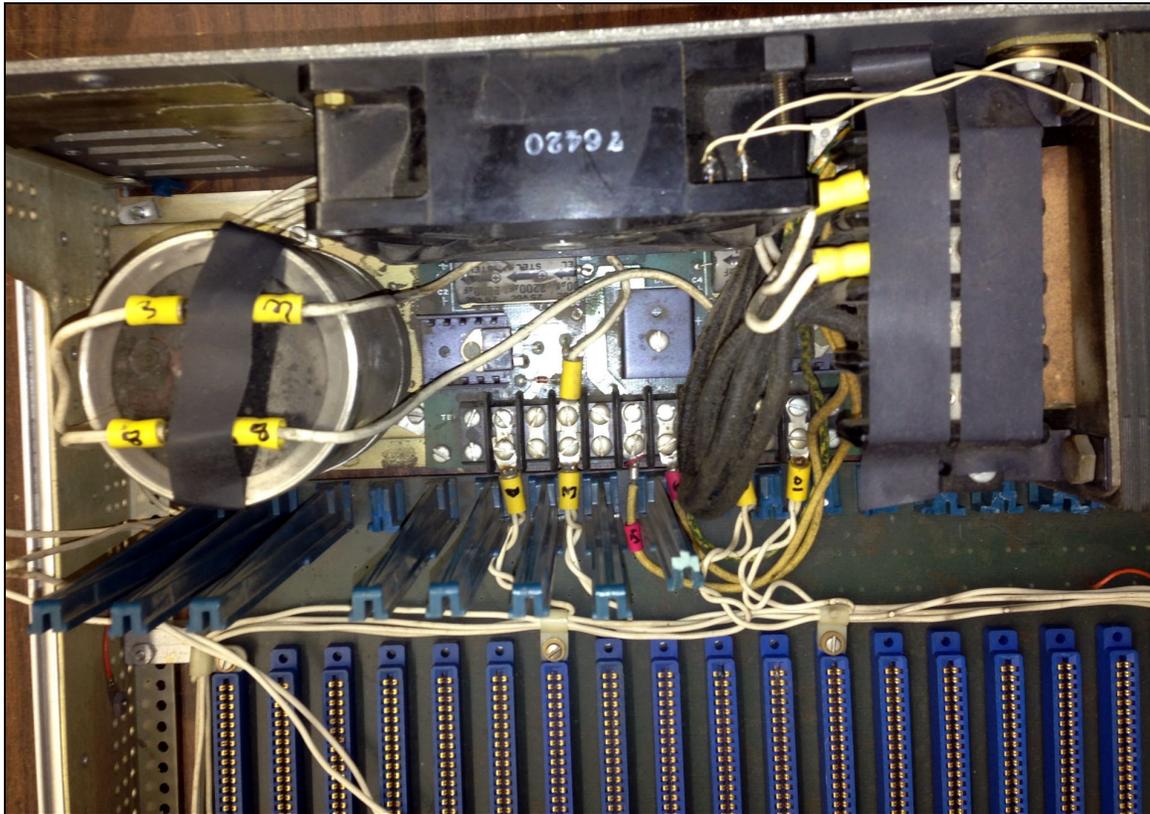
The -16v supply in the computer was not working. The +/-16v supplies are generated by a power supply board. This board can be seen in the picture below between the large filter capacitor on the left and the transformer on the right.

Pass transistor Q1 for the negative supply had failed. I replaced the original TIP145 with a TIP147. The TIP147 is the same as the TIP145 with a higher voltage rating. The TIP147 is also much more readily available these days. Likewise, a TIP142 can be used to replace the original TIP140 for the +16v supply. These parts are now in a full plastic case (the metal tab package is no longer made), but the lead dimensions and hole location are still the same.

The -16v supply was most likely damaged by a shorted tantalum capacitor on the -9v supply on the front panel board. See the “Front Panel Repairs” section for details.

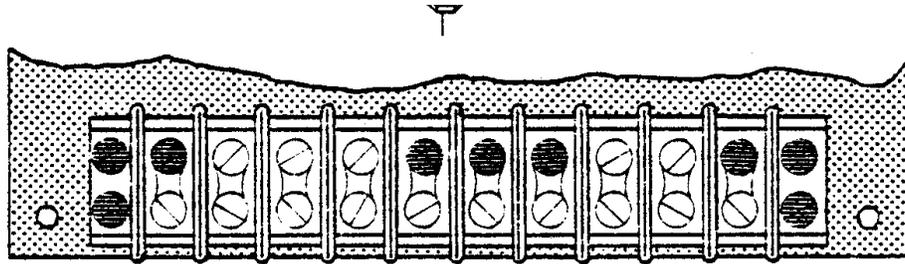
5-41. Power Supply Terminal Block  
Screw Insertion

Second, if you are removing/attaching wires to/from the power supply board barrier strip, do not loosen/use the screws shown in black in the figure below. These screws have nuts on the back side of the board and you'll have to disassemble the computer and remove the power supply board in order to re-tighten them properly.

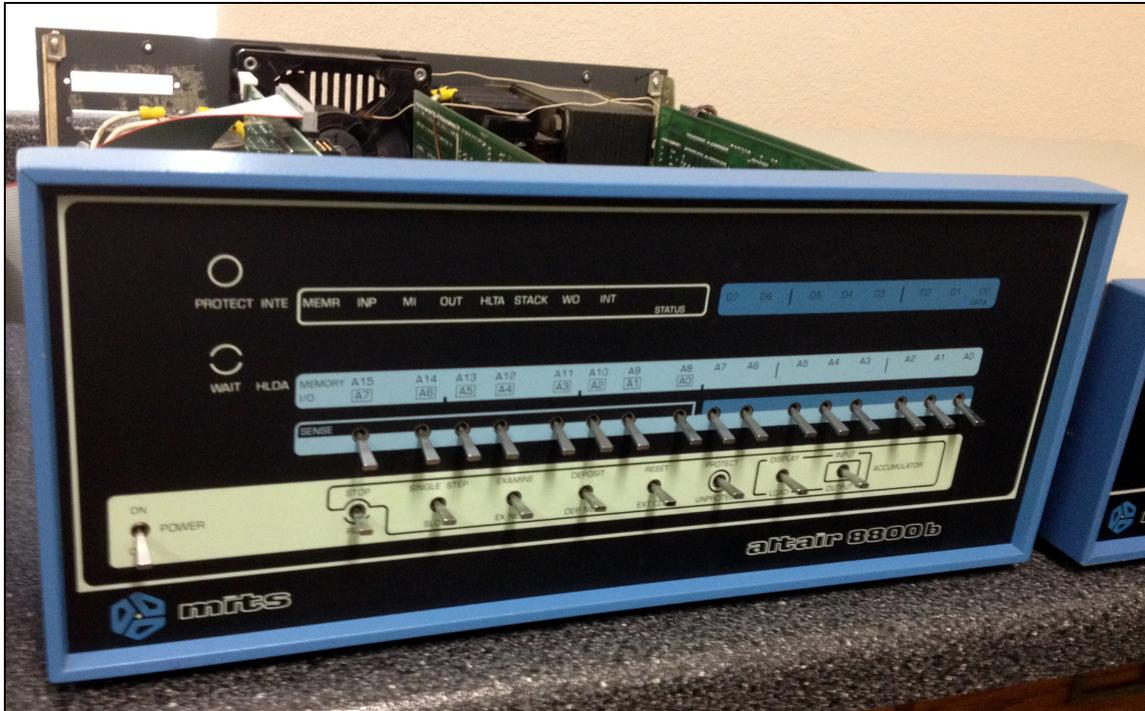
### Front Panel with New Switches

The front panel power switch had been replaced with a switch that has the shorter, round baton found on the original 8800. I replaced the switch with a power switch that matched the long flat baton of the other 8800b switches. I also replaced one of the address switches that was defective.

The front panel PCB required replacement of C2 (22uf tantalum on the -9v regulator). The original cap had burnt completely. This failure is most likely what took out the computer's -16v supply.

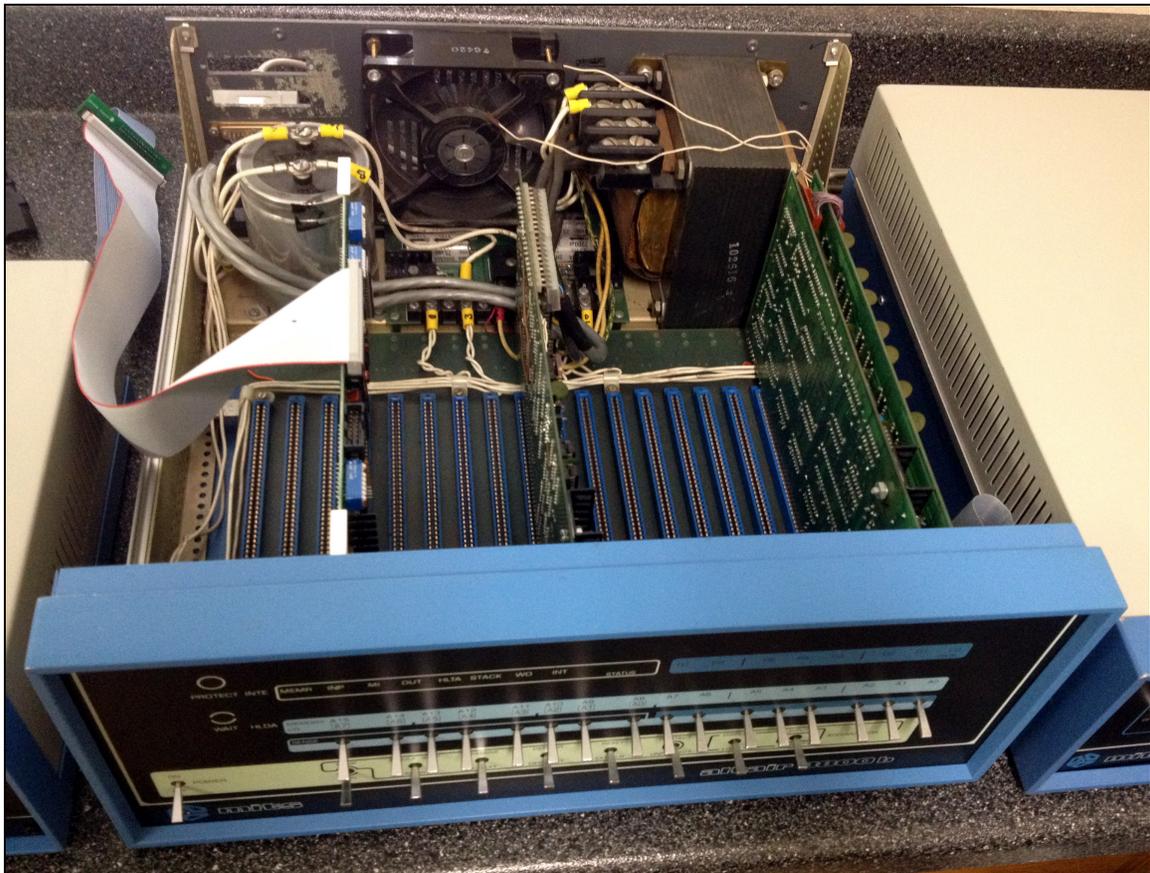
After many hours of use, the computer worked reliably with the majority of board configurations I loaded in the computer. However, I occasionally had flakey behavior with a thin load of boards like shown below. After studying symptoms and bus signals, I isolated the problem to IC "P" on the CPU board (an 8T97) that drives A15,13,11,9 and D0,D2 on the bus. I replaced the 8T97 with a 74LS367 and the problems went away. I've seen failed or marginal 8T97's in a number of computers. The 74LS367 is a good drop-in replacement.

In the picture shown below, boards from left to right are: Altair FDC+ (includes RAM and ROM), 88-2SIO, 8800b CPU, Front Panel Interface
