OBJECT	DATE	NUMBER
Systems Turnkey module malfunction	10/9/79	007
PRODUCT AFFECTED All systems turnkey module PCBA's P/N 200372-01

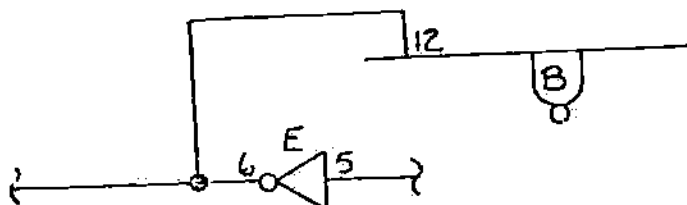
200374, SHEET 1. ZONE 7C REVISE:

The new systems turnkey module P/N 200372-01, will disable the prompts if an I/O instruction is executed from prom location. This means that the systems turnkey module will not function properly with certain programmed prompts. To avoid this particular malfunction, you must install the following modifications:

FROM:
