Field Change Notice

Number 1
 Date APRIL 15, 1982
 Page 1 of 4

Models Affected: ADVANTAGE Class of Change: MANDATORY
 Assembly(s) Affected: ADV BASE ASSY Field Action: INSTALL ON NEXT CALL
 Factory Implementation: 5-1-82 Est. Install. Time: 0.5 Hrs.

ADVANTAGE GROUNDING RETROFIT INSTRUCTIONS

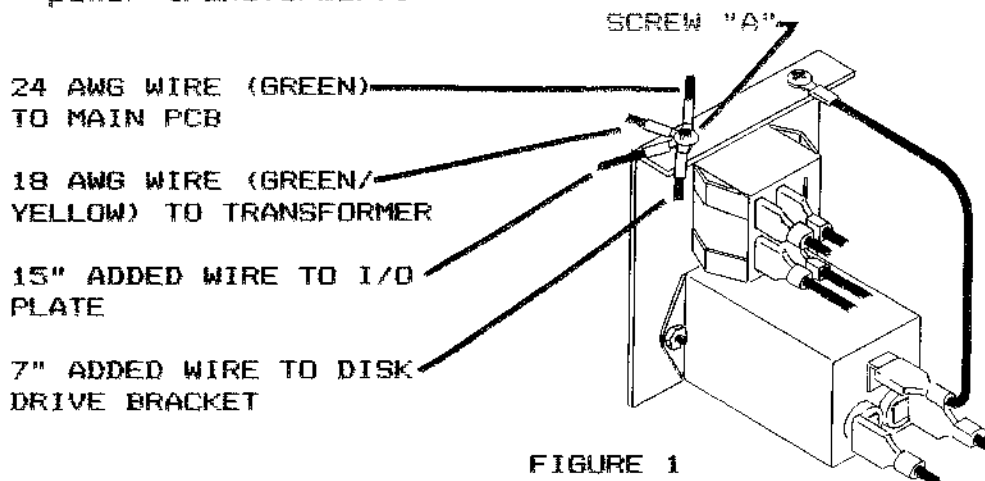
Provide adequate grounding between I/O plate, AC power panel and chassis of Advantage Computer. This change is mandatory to conform to UL & CSA standards. Without this modification, equipment could be damaged under certain short circuit conditions.

1. Disconnect the Advantage from the AC power source.
2. Remove the top cover of the Advantage as described in Section 6.5.2 of the Advantage Technical Manual (North Star P/N 00464).
3. Using Figure 1 as a reference, remove screw A on the AC power panel. (NOTE: this screw already secures two (2) wires, one solid green 24 awg wire going to the main PCB connector and one green/yellow 18 awg wire going to the power transformer).

4. Attach one end of each of the two wires supplied in the kit to the screw removed in step 3 along with the two wires already attached to the screw and replace the screw on the AC power panel.
5. Using Figure 2 as a reference, remove screw A on the I/O mounting panel. Discard this screw.
