COMPOSITE OF EXPANDORAM II MODIFICATIONS

TECHNICAL BULLETIN NO. 105

APRIL 1980

EXPANDORAM II

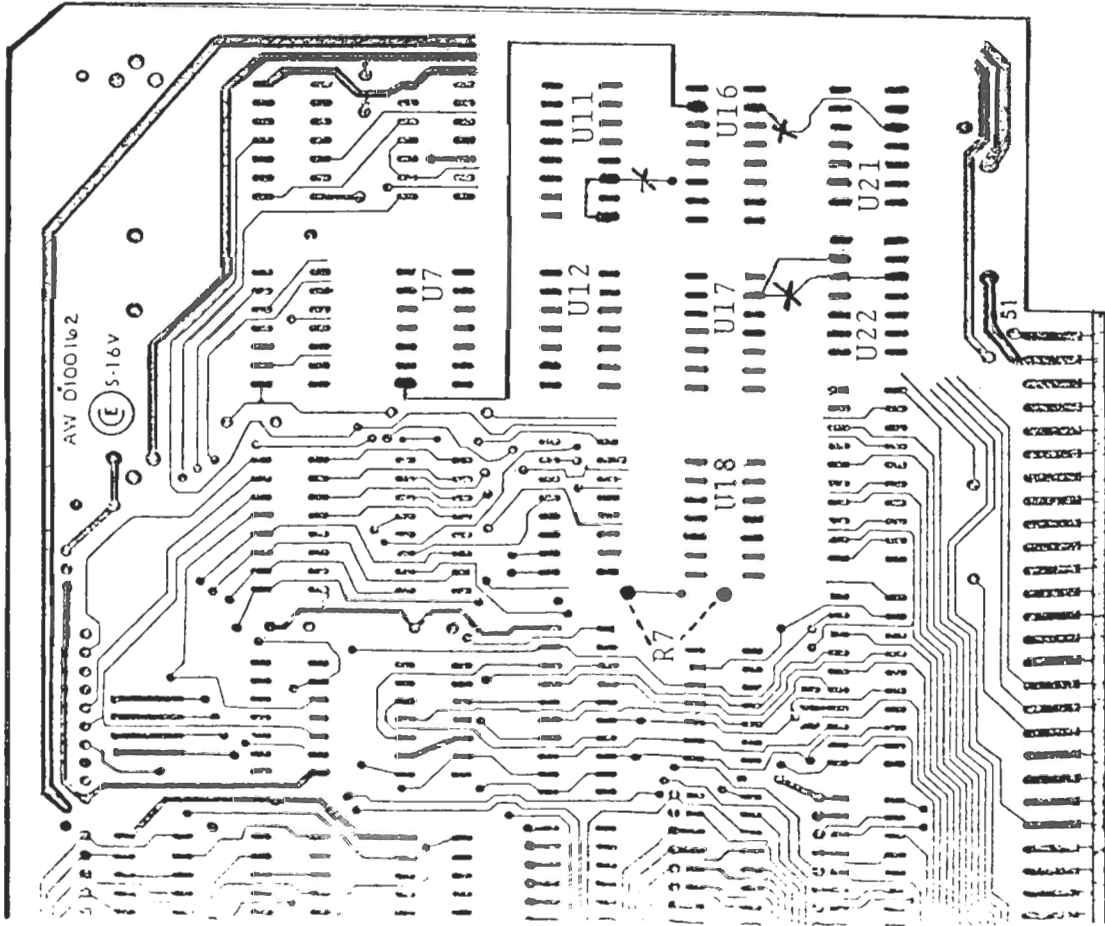
MODS TO BE MADE TO THE EXPANDORAM II

Extensive field usage and further R&D in our engineering department has determined that the ExpandoRAM II could hang up in Wait State Refresh cycles under certain conditions. The modifications delineated below solve this problem:

1. Examine diagram to left and locate the three traces marked with an 'X'. Double check to ensure that you have the correct traces and then cut them with a sharp knife. Make the cut deep and 'v' shaped to make sure that the connection is broken.

2. Locate U7; note the only connection and follow it to U16. Using an insulated wire, complete the connection as shown.
3. Locate U11; note the only connection is a jumper between two pins on U11. Using an insulated wire, complete the connection as shown.

4. Locate U17; note the new connection and follow it to U22. Using an insulated wire, complete the connection as shown.
5. Locate R7 to the left of U18; its solder points are indicated by dotted lines. Remove R7 and replace it with the 20K Ohm resistor provided.

6. Turn your PC board over and locate U6. With a small flat blade screw driver, gently and slowly pry U6 out of its socket. Note the way it is placed in the socket. Using the replacement IC provided, line up all pins with the socket. Be sure that the replacement IC is in the correct position and then push it into the socket firmly. Examine closely making sure no pins were bent.
