TITLE DOOR OPENER BAIL HEIGHT ON FRONT LOAD DISK DRIVES			PIB NO. DK-3019	
PRODUCT LINE TAPE DISK FORMATTER	EQUIPMENT CHANGED 102624-01	MODEL SERIES AFFECTED D3000	EFFECTIVE DATE 1-15-75

TITLE DOOR OPENER BAIL HEIGHT ON FRONT LOAD DISK DRIVES

FIB NO.
DK-3019

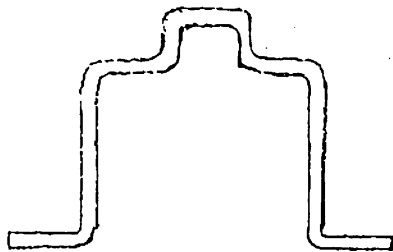
Figure 1

DESCRIPTION: The door opening mechanism (P/N 102624) has been re-designed to avoid a possible worst case condition involving 2315 type front load disk cartridges. ANSI (American National Standards Institute) specifications require that the access door be opened 1.650 inches, (41.91 mm) minimum. There is, however, no dimension for the height of the retainer to the sector hub once the access door is open. Therefore, the possibility could exist that a marginal pack could possibly make contact between the retainer and the sector hub. The redesigned door mechanism will open the access door wider by approximately .030 prohibiting any worse case conditions. Figures 1 and 2 will portray physical differences of old and new style respectively.
