TITLE EXCESSIVE OVERSHOOT/SETTLE TIME DELAY REGISTER				PIB NO. DK3025
PRODUCT LINE	TAPE DISK FORMATTER	EQUIPMENT CHANGED All Logic PCBA's	MODEL SERIES AFFECTED D3000	EFFECTIVE DATE 2-14-75
CLASS OF BULLETIN: <input type="checkbox"/> IMPROVEMENT <input checked="" type="checkbox"/> RETROFIT ON FAILURE <input type="checkbox"/> RETROFIT RECOMMENDED <input type="checkbox"/> SERVICE INFORMATION ONLY		ORDER PART KIT NO. N/A	EFFECTIVITY D3000's prior to S/N 1000	
PURPOSE: There have been some isolated cases where a particular D3000 would exhibit excessive overshoot and become one track off. Recent changes may possibly correct this condition on units prior to S/N 1000. UI09, the settle time delay register, can have its time factor shortened. By shorting this settle time, reducing the velocity and leaving the base seek time at approximately 35 milliseconds, the positioner will actually move slower. Results are the present overshoot is cut to a minimum, with no loss in seek performance. Because of the isolated number of instances, "Retrofit on Failure Only".

TITLE EXCESSIVE OVERTHOOT/SETTLE TIME DELAY REGISTER

PIB NO.
DK3025

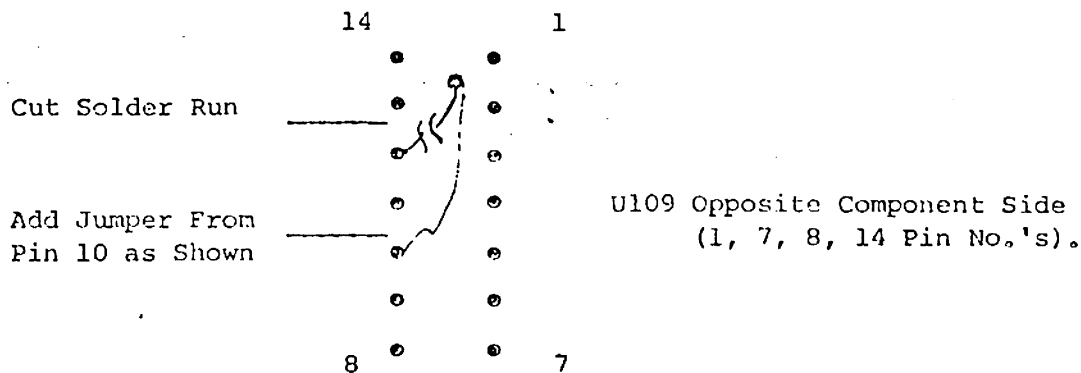
FIGURE 1

SYMPTOMS: <ul style="list-style-type: none"> - Correct sector but one track off - Addressing errors - Formatter errors - Address compare errors - Unexplainable controller time-outs 				
PARTS REQUIRED: <ul style="list-style-type: none"> - Approximately one (1) inch of jumper wire 30 AWG, silver plated copper wire, Mylar insulation 				
TOOLS REQUIRED: <ul style="list-style-type: none"> - Soldering iron with 25 to 27 watt tip 				
REWORK INSTRUCTIONS: 1.0 Perform all servo adjustments and ensure overshoot is to the minimum. (Ref: D3000 Manual, 102780, Section 6) 2.0 Locate I.C. UI09. (Opposite component side) 2.1 Cut etch to Pin 12 (see Figure 1).

- 2.2 Add jumper from Pin 10 to output etch as shown in Figure 1.
- 2.3 Perform in D3000 Service & Maintenance Manual, Section 6, SEEK TIME FINAL ADJUSTMENTS.
