TITLE CONNECTOR HARNESS STRAIN RELIEF				PIB NO. DK 3045	
PRODUCT LINE:	TAPE DISK FORMATTER	<input type="checkbox"/> <input checked="" type="checkbox"/> <input type="checkbox"/>	EQUIPMENT CHANGED D3000	MODEL SERIES AFFECTED D3000	EFFECTIVE DATE July 1, 1975

TITLE CONNECTOR HARNESS STRAIN RELIEF

PIB NO.
DK3045

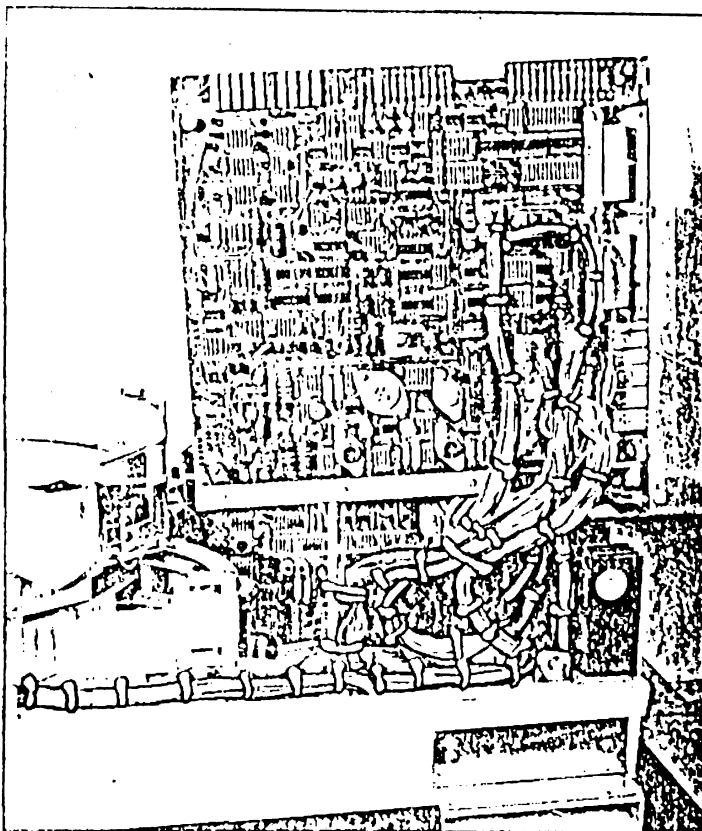
FIG. 1

Folding down the Logic and Servo PCBA's can, in some circumstances, cause the Molex connectors, to ease off their mating pins. Repeated opening and closing of the PCBA's can result in intermittent contact being made to these pins.

Showing unit before tie wraps are removed.
Top Load unit pictured,
but improvement applicable
to Front Load units also.

This effect can be overcome by the simple operation of removing some of the tie wraps, and making the connector harness less rigid.

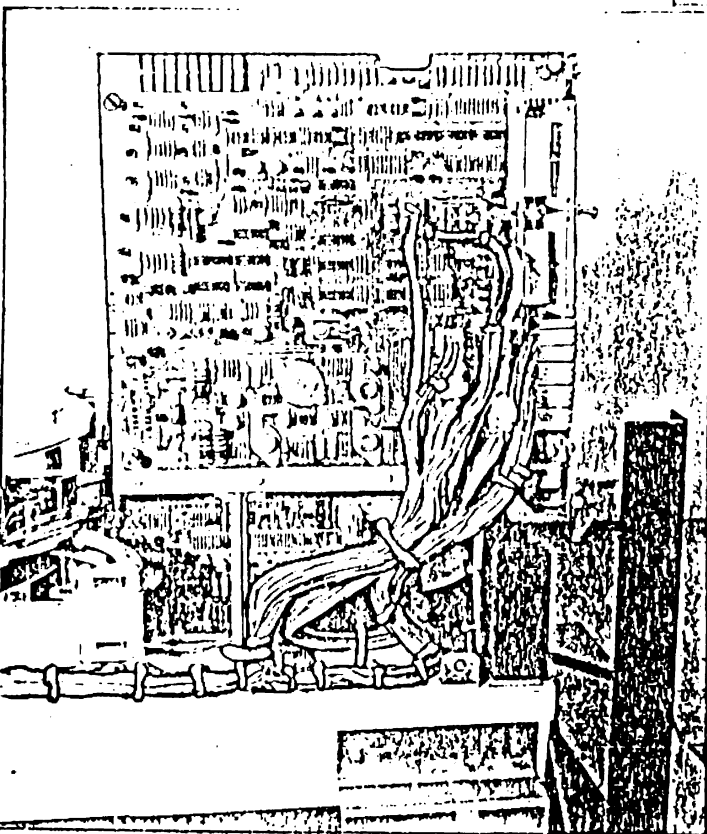
FIG. 2

Unit shown with minimum number
of tie wraps necessary to
keep connector harness tidy.

Note: 15 tie wraps have been
removed.
