# SERVICE LETTER

NUMBER: DK3010

SUBJECT: D3000 SPINDLE CENTRICITY

PRODUCT AFFECTED: All D3000 Disk Drives

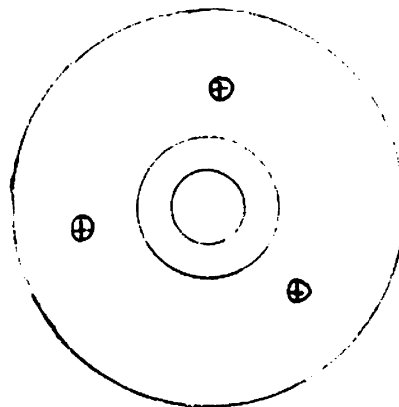
FIGURE 1

Incidents have been reported where the three Phillips head screws in the top of the spindle assembly have been either loosened or removed in an attempt to remove the spindle (see figure 1). Loosening of these screws causes the spindle assembly to become eccentric if only minutely.

ACTION: When removing the spindle assembly from a disk drive or performing any maintenance associated with the spindle do not loosen the end of the three Phillips screws on the top of the spindle.
