SERVICE LETTER

NUMBER: DK3038

To inform field personnel of the method to be used to measure the asymmetry of D3000 Read/Write chain using the dual one shot Read/Write PCBA, 103751.

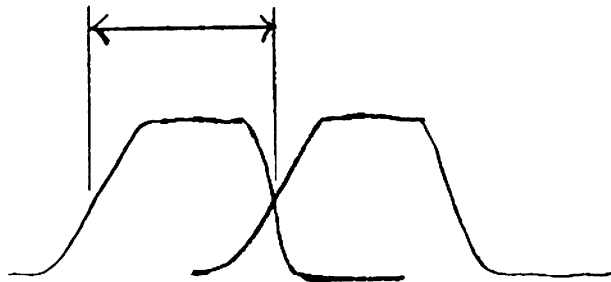
PULSE PAIRING

- Using delayed trigger mode, expand one of the pulse pairs to 50 ns/div. sweep rate, or if possible, to 20 ns/div.
- Measure the time interval between the leading edge of these pulses. This interval is defined as the pulse pairing error.

- Repeat this measurement for each of the remaining heads. The pulse pairing error shall not exceed specifications listed below.
1500 RPM = ≤ 90 NS
2400 RPM = ≤ 56 NS
- If pulse-pairing specifications cannot be met, head replacement is required. Verify that new head(s) are in accordance with this specification.
