TO: ALL VECTOR GRAPHIC DEALER/SERVICE DEPARTMENTS

HARDWARE BULLETIN NO. #80-1

RE: Z80 CLOCK CIRCUIT FAILURE

HARDWARE BULLETIN NO. #80-2

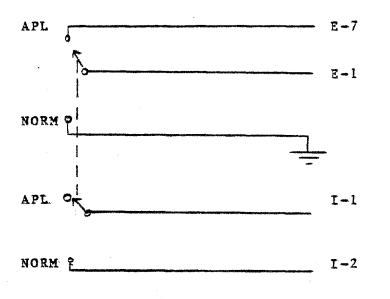
### I. For TMS 2716 proms only -

A) Add switch as shown below

B) Cut Etches

Jumper from:

-	
II to	I2.	B 1	to	B 2
El to	E4.	E1	to.	E3
E2 to	图5.	E 2	t.a	E 6
E3 to	E9:	E.S	to	U22-18
trace	from U22-18

C) Insert APL PROMs at U22 and U23

Use APL TMS 2716 at U22. Use APL 2708 at U23

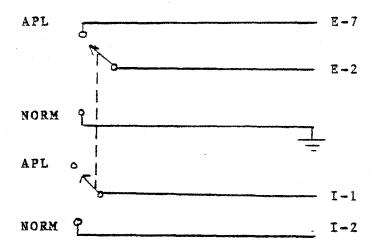
### II. For INTEL 2716 or TMS 2516 only -

A) Add switch as shown below

B) Cut etches.

Jumper from

I1-I2 E1-E4 E2-E5

B1-B3 E1-E5

C) Insert APL PROMs at U22 and U23

Use APL TMS 2516 or INTEL 2716 at U22 Use APL 2708 at U23

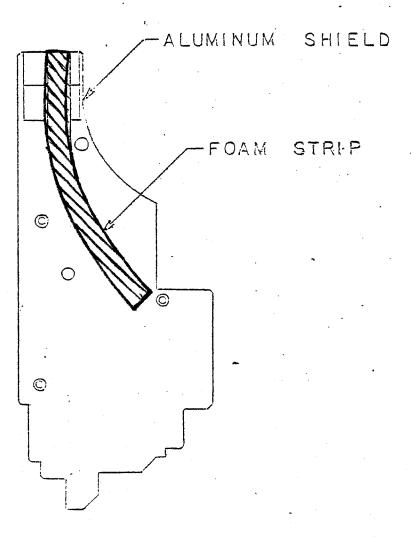
FIGURE 2

Description: Certain components on the motor control board and device electronics

board were found to need additional air flow for proper cooling. This is accomplished by installing the foam tape as described in

figures 1 and 2.

- 5. Install the longer piece of foam (approximately 6" in length) as illustrated in Figure 2.\*
- 6. Be sure to remove all foam tape backing material from the inside of the drive.
- 7. Lower the hinged board assembly and tighten the three large slot head screws.

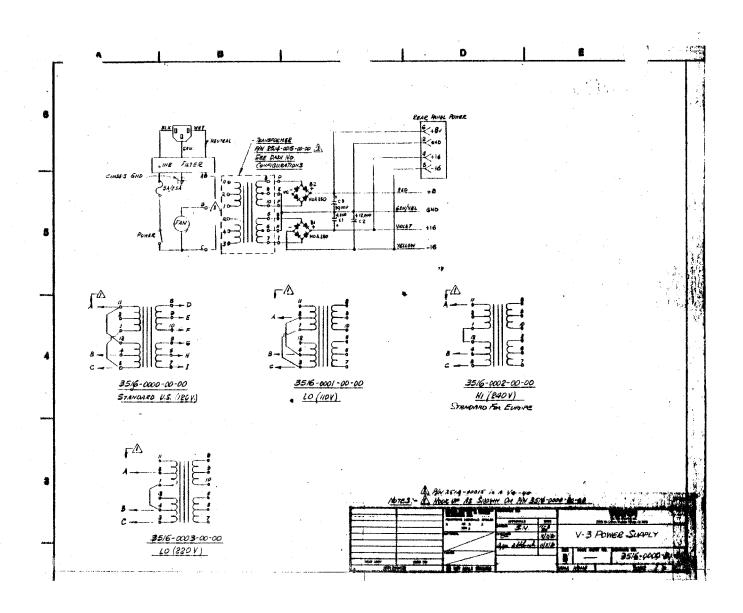
#### V-3, VG-4G TRANSFORMER

Vector has upgraded the Vector 3 from a VG-4 to a VG-4G. The VG-4G is slightly larger and has a higher rating. This was done to prevent the transformer from affecting the display in 220V. versions. Note that the connections are different than the VG-4.

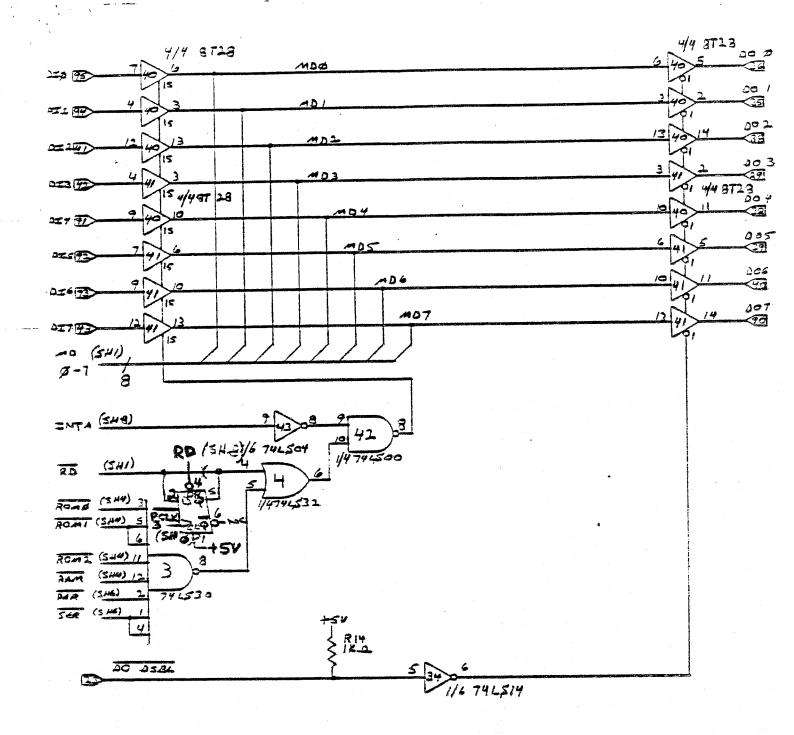
#### REV 3 ZCB

The Revision 3 ZCB board is now in production at Vector. This Revision was implemented in order to delay the RD signal, which was creating a race condition that caused a data glitch. This "glitch" could create memory errors that were attributed to the 64K PCB. This revision is a factory only modification. The error condition is apparent when a 64K PCB is swapped or the LS244's are changed to resolve a memory error, but the original 64K PCB functions properly with a different ZCB board. The attached schematic should be added to your ZCB documentation.
