Altair 680 Capacitor C4 Discharge Mod

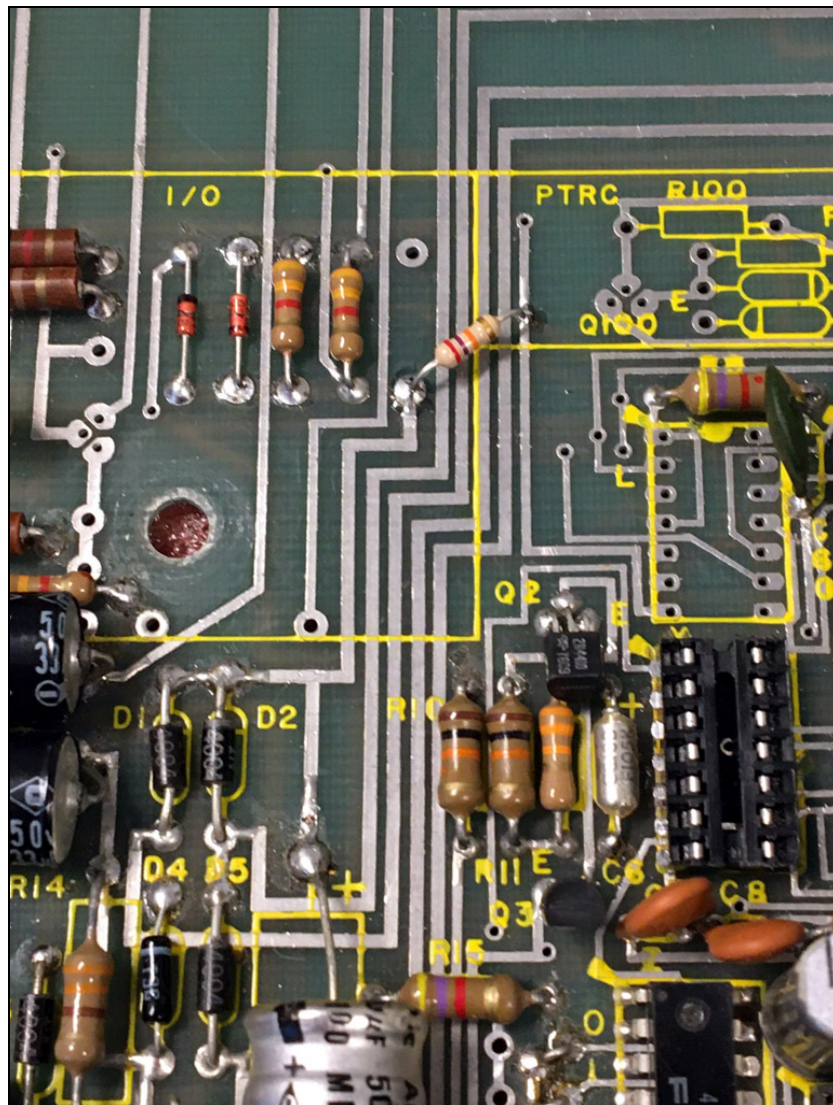
After lots of experiments and head scratching, I finally figured out the damage was occurring when I inserted a memory board while the system was OFF! Capacitor C4 on the main board is the +16v filter cap. Nothing on the main board drains that capacitor and the +19v or so sitting on that 100uf cap is sufficient to cause the part failures when inserting the memory board.

An easy solution is to install a 27K or so resistor across C4. A convenient place to install this resistor is shown below (the diagonal resistor). You can see the + end of C4 at the bottom of the picture.
