Restoration and Repair of a North Star Horizon Computer

The Horizon is a Z80 based computer made by North Star. Many were shipped with wood covers, however the one I picked up has a blue metal cover. The computer came with all North Star brand S-100 boards: Z80 CPU board (ZPB-A), DSDD floppy controller (MDS-A-D), 1 x 32K RAM (RAM-32-A) and 2 x 16K RAM (RAM-16-A). The motherboard includes two serial I/O ports and two parallel ports. Finally, two Tandon 100-2 floppy drives (DSDD, 360K) are mounted through the front panel.

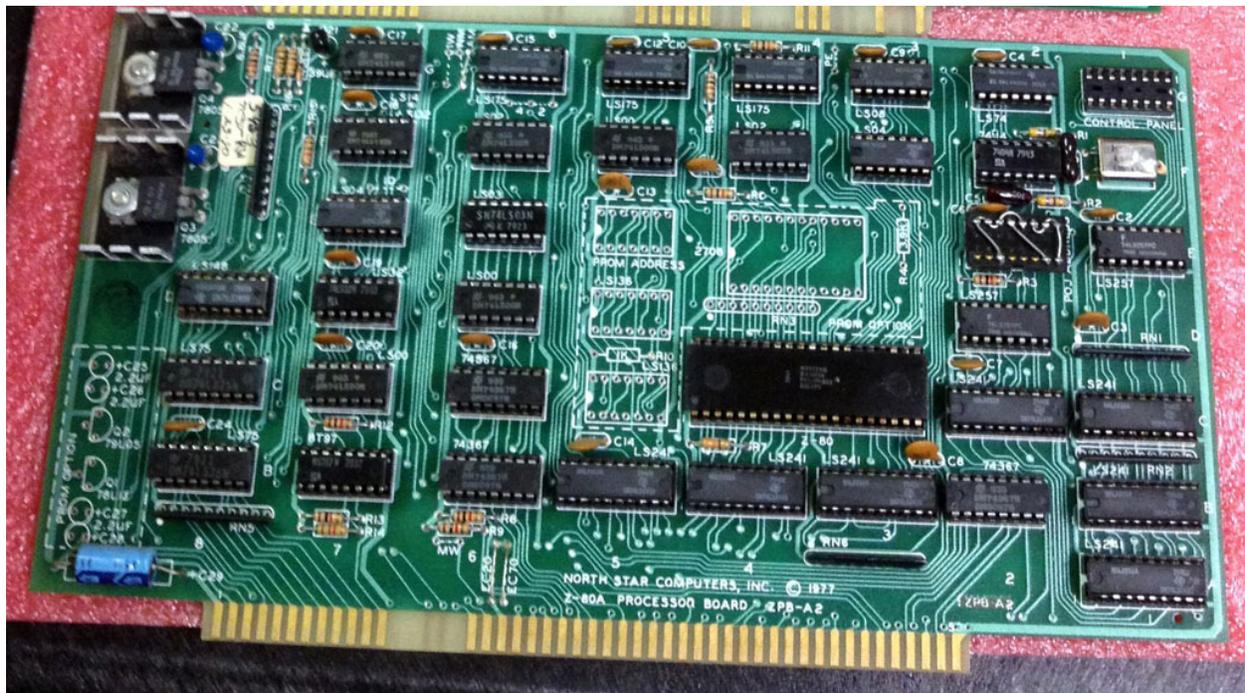
The North Star ZPB-A CPU board provided with the Horizon has an un-populated PROM option that allows installation of 2708 EPROM. The vacant PROM option can be seen in the center and bottom left corner of the CPU board shown below. Installation of the PROM option requires two regulators to generate +12v and -5v for the 2708, a couple of 74LS136's for address decoding, and the 2708 itself. I could install these parts, but I still needed to find/write a monitor for the Horizon.

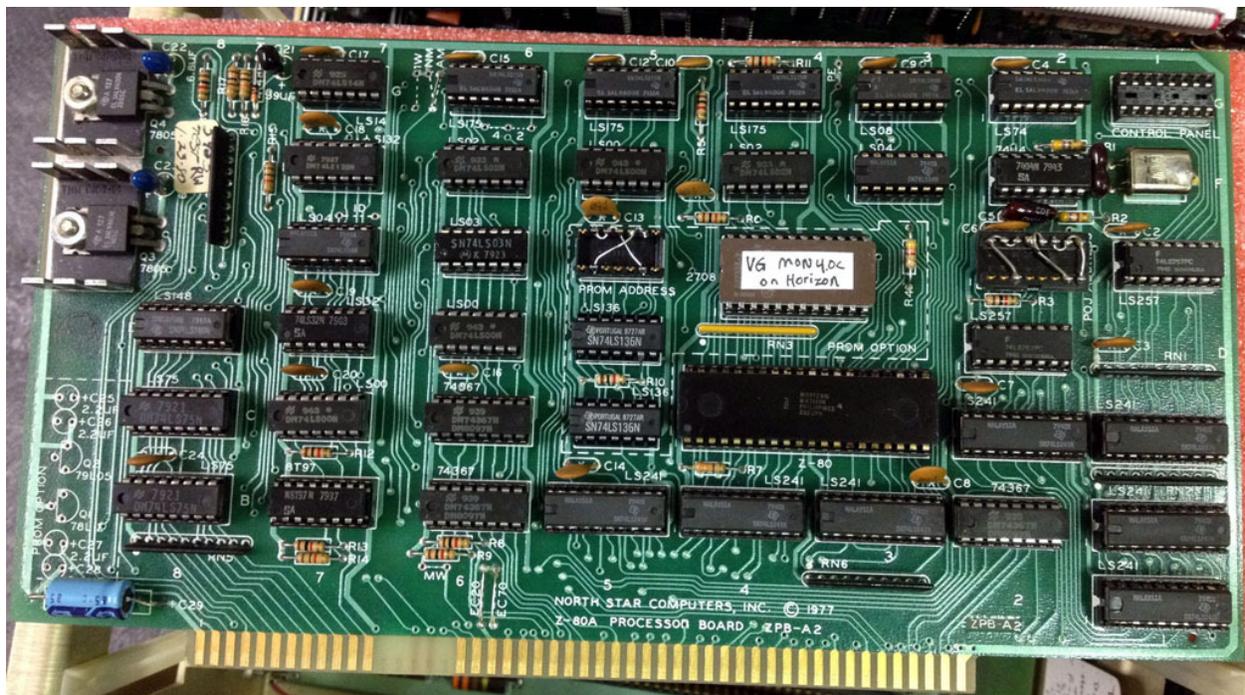
The CPU board with the 2716/2732 PROM option installed is shown below. Note that the regulator components at the bottom left are not installed. I installed R4 and the resistor pack RN3, however, it turns out they are not needed with a 2716 or 2732 EPROM. These pull-up resistors were required to ensure the input voltage for a data “1” exceeded the 2708’s threshold of 2.4v. This input spec is not fully TTL compatible. The 2716 and 2732 have a voltage threshold of 2.0v for a data “1” which meets the TTL spec and the pull-up resistors are not required.

The following steps were performed to add a 2716/2732 EEPROM to the CPU board:

- 1) Cut the “PE” (PROM Enable) trace near top of board.
- 2) Install resistors and sockets for the PROM option. Do NOT install the power related parts for the PROM option (e.g., the two regulators and capacitors at the bottom left of the board).
- 3) Wire IC 5D-P4 to 4E-P19. This puts A10 on pin 19 of the EPROM socket (A10 on the 2716 and 2732).
- 4) Wire IC 4E-P24 to 4E-P21. This puts +5v on pin 21 of the EPROM socket (Vpp on 2716, A11 on 2732).
- 5) Wire PROM address header as required for the desired EPROM address. E000 requires 13, 12, and 11 to 6 or 7, and 10, 9 to 1 or 2.
- 6) Wire auto-jump header as required for EPROM entry. E000 requires 16, 15, 14 to 3 or 4, and 13-9 to 7 or 8.
- 7) Install IC’s in sockets, lifting pin 6 of IC 5D out of the socket during insertion. This prevents A10 from affecting the PROM selection signal.

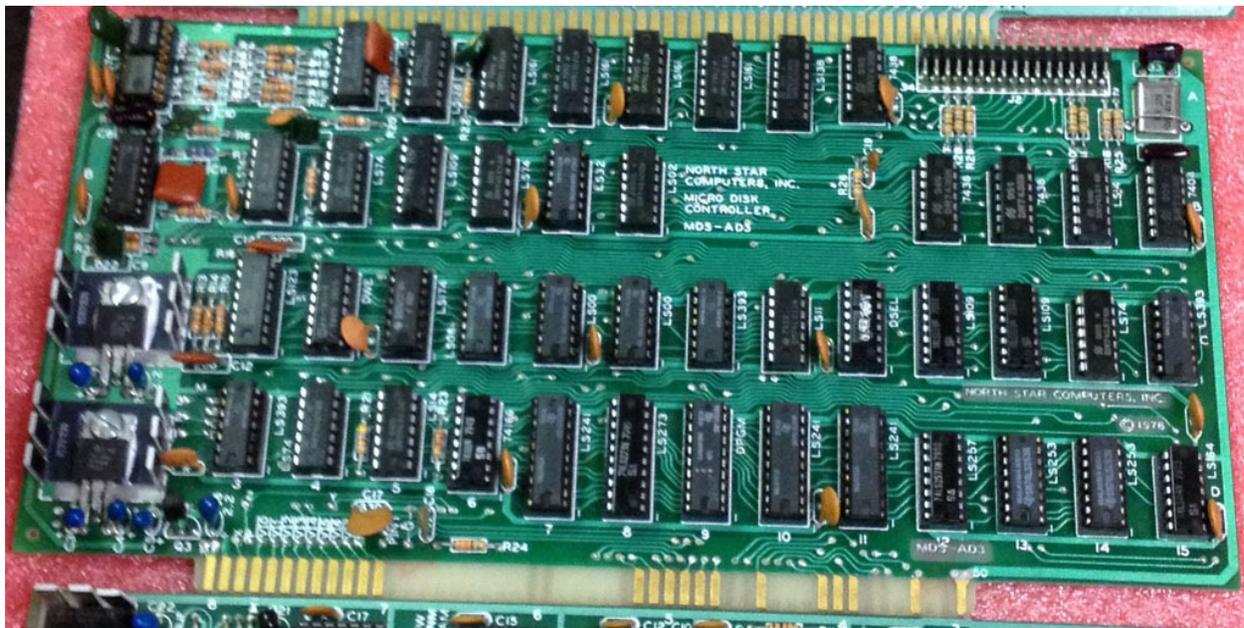
The Horizon computer came with the North Star DSDD floppy disk controller (MDS-A-D). This is a hard sectored controller using ten sector disks. I had already tested the FDC in a Sol-20 computer using known-good drives and the FDC is fully functional.

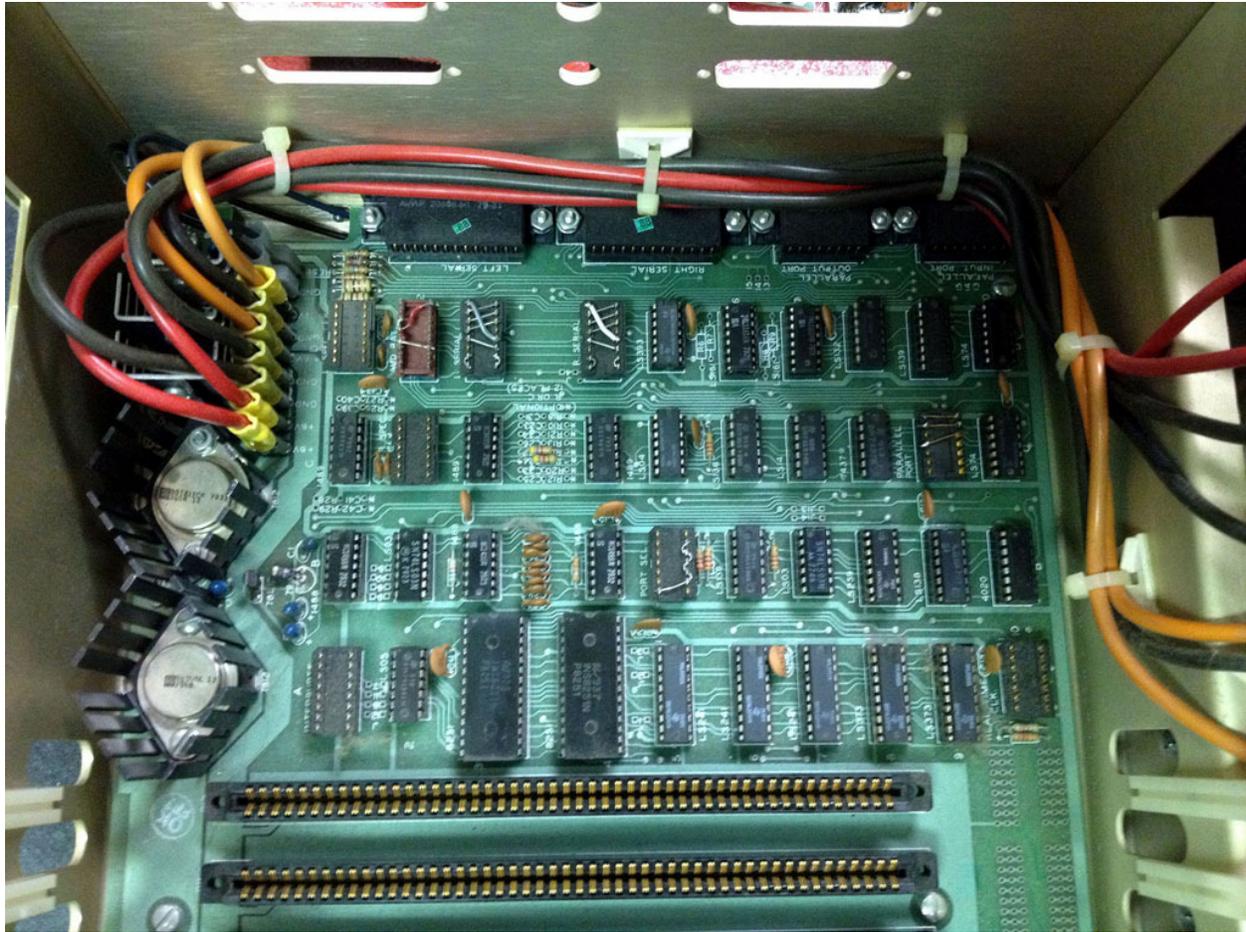
The motherboard in the Horizon includes hardware for two serial ports and two parallel ports. The serial ports use the 8251 UART. Headers allow configuration of DB-25 pin assignment and baud rate for each of the two serial ports. Both ports were configured as DCE with the console port at 9600 baud and the 2nd port at 300 baud. I modified the baud rate header to run the 2nd port at 9600 baud instead of 300 baud. The following picture shows the I/O hardware that is part of the motherboard in the Horizon computer.

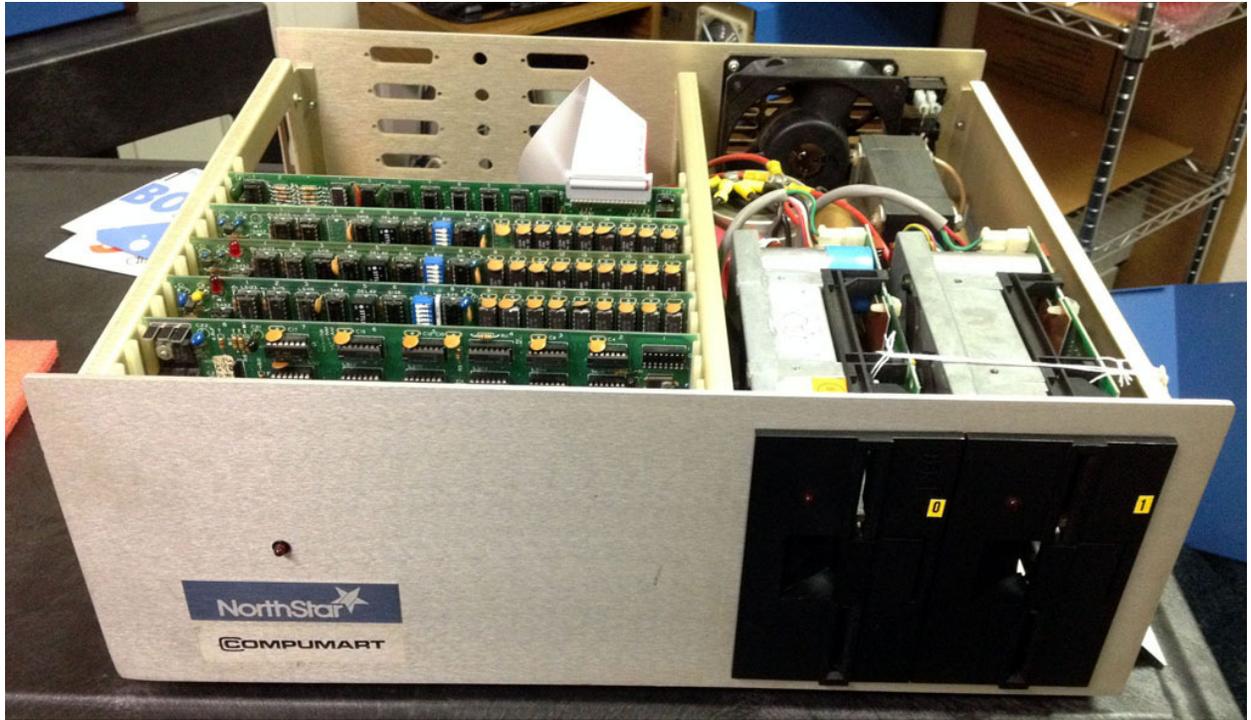
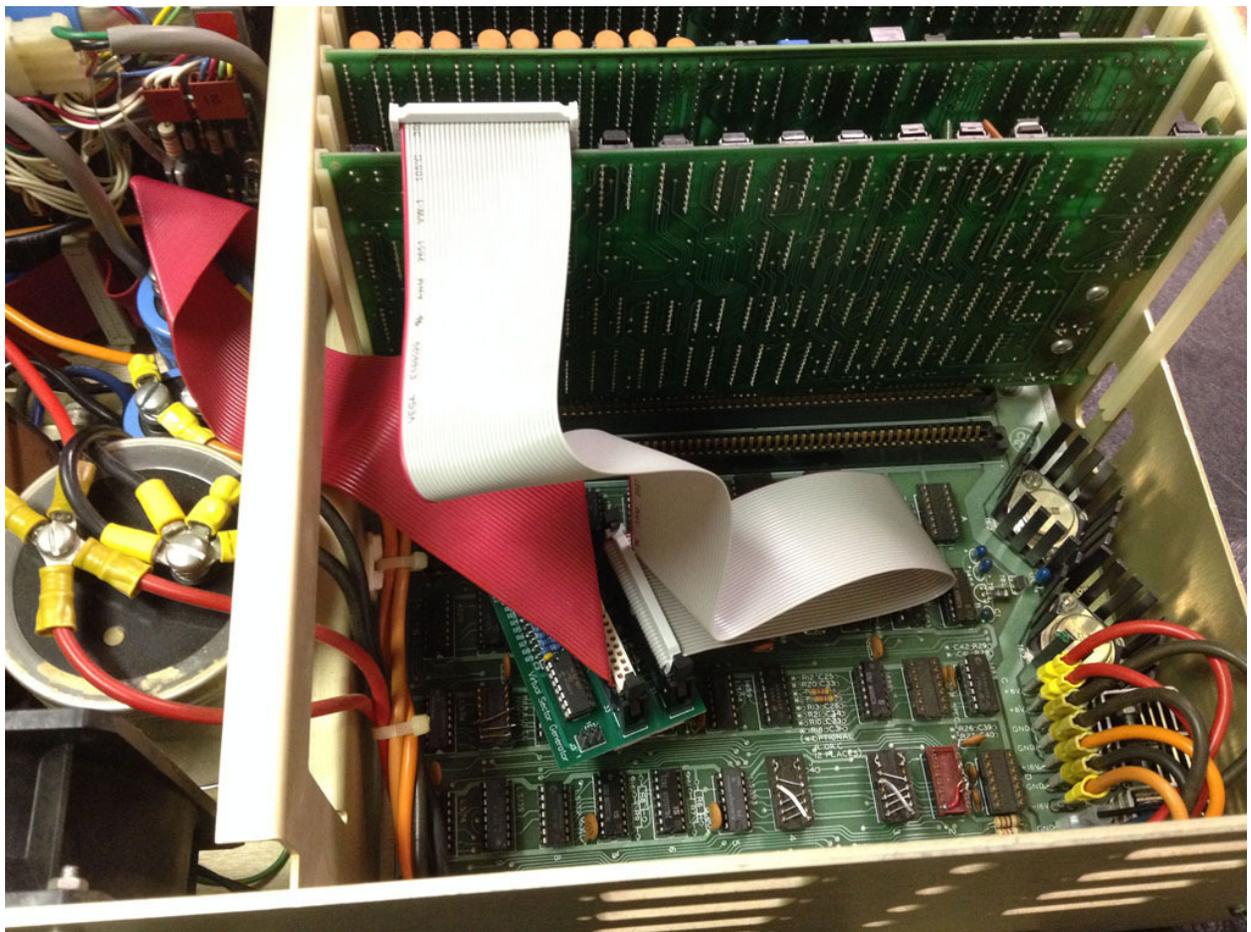
On the following page are pictures of the restored Horizon configuration with all original boards and hardware functioning. The second picture shows the Virtual Sector Generator (VSG) board in-line between the FDC and the drives so that soft-sectored media can be used in addition to 10-sector media since the latter has become so hard to find. See <http://deramp.com/vsg.htm> for more information about the VSG.
