Altair 8 inch Floppy Drive Restoration Notes

This is a later version of the Altair floppy that uses ribbon cables and IDC connectors internally instead of hand-wired ribbon cables. The buffer board combines the buffering electronics with the power supply electronics on a single board. Both the front panel and the buffer board include a write protect LED position, so if the drive is equipped with the write protect electronics, the front panel LED should illuminate when protected.

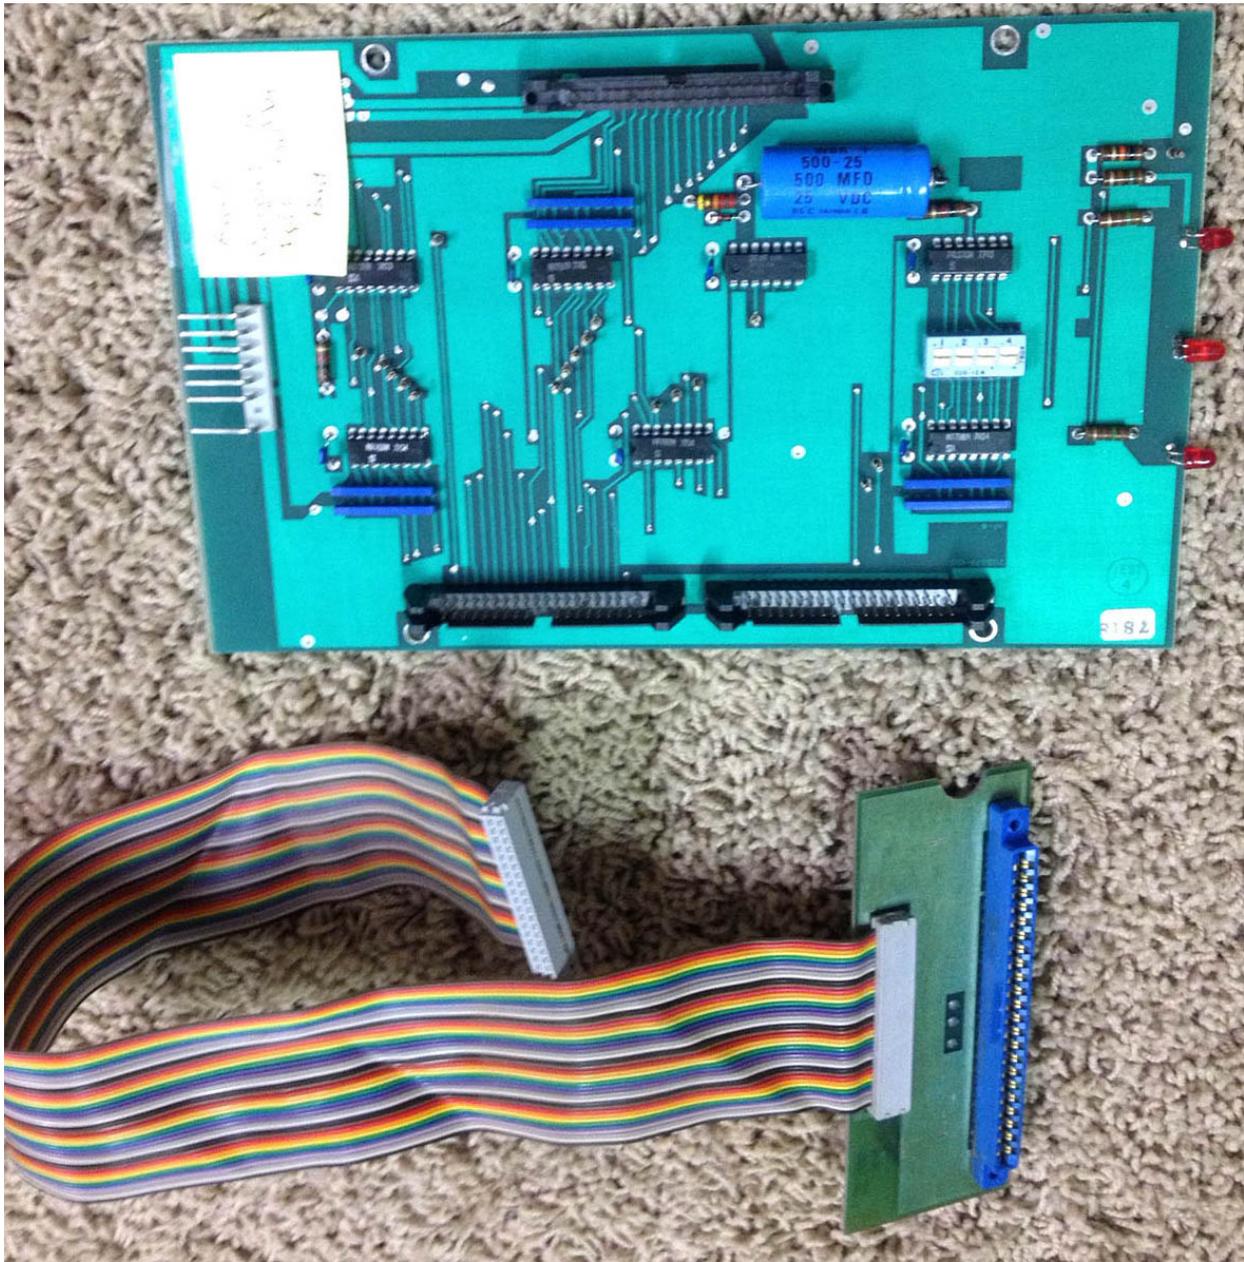
Buffer Board from a 3202 Dual-Drive Cabinet

A photo of the 3202 buffer board and the drive adapter cable is on the following page. Note the similar layout of the IDC connector and components compared to the photo above. The 3202 board does not have the write protect LED and the power supply electronics are not part of the board.
