TO: ALL VECTOR GRAPHIC DEALER/SERVICE DEPARTMENTS

HARDWARE BULLETIN NO. #80-1

RE: Z80 CLOCK CIRCUIT FAILURE

HARDWARE BULLETIN NO. #80-2

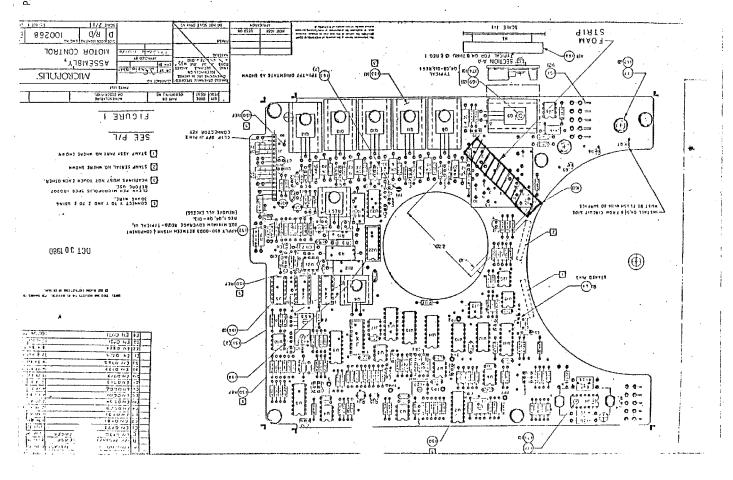
FIGURE 2

board were found to need additional air flow for proper cooling. This is accomplished by installing the foam tape as described in

- 5. Install the longer piece of foam (approximately 6" in length) as illustrated in Figure 2.\*
- 6. Be sure to remove all foam tape backing material from the inside of the drive.
- 7. Lower the hinged board assembly and tighten the three large slot head screws.
